KENT JACKSON

Confidential Inspection Report

64 TRE # 13
Crapaud, P.E

July 6, 2014

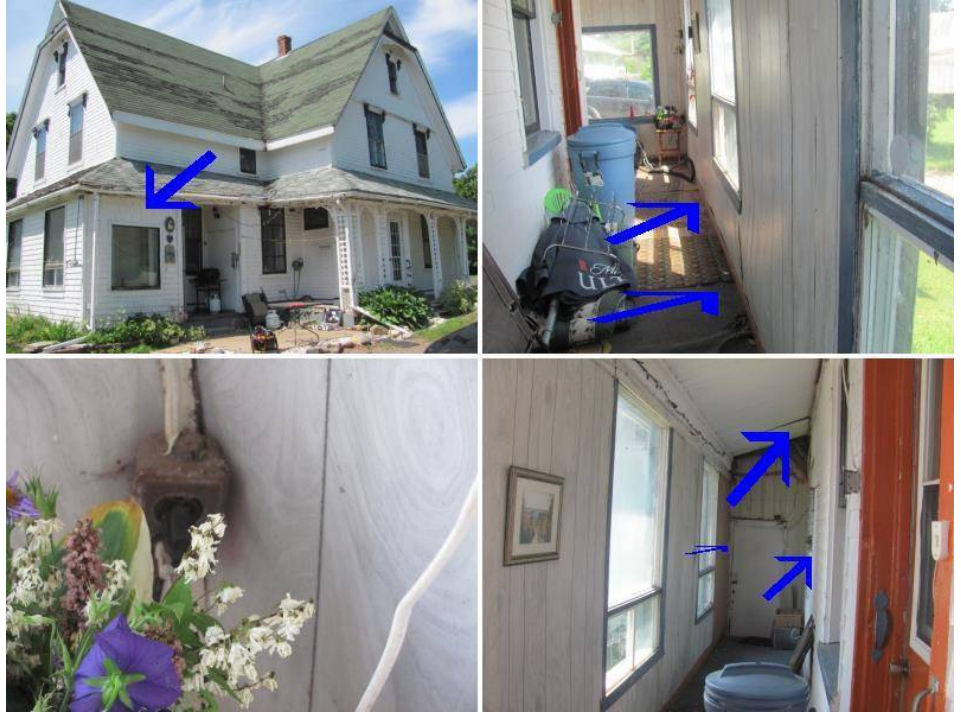
Floor

Wood --this is in need of major repairs-- Cracks noted - major, Portions missing, Sloped toward building, Poor drainage noted. Flooring restricts viewing.

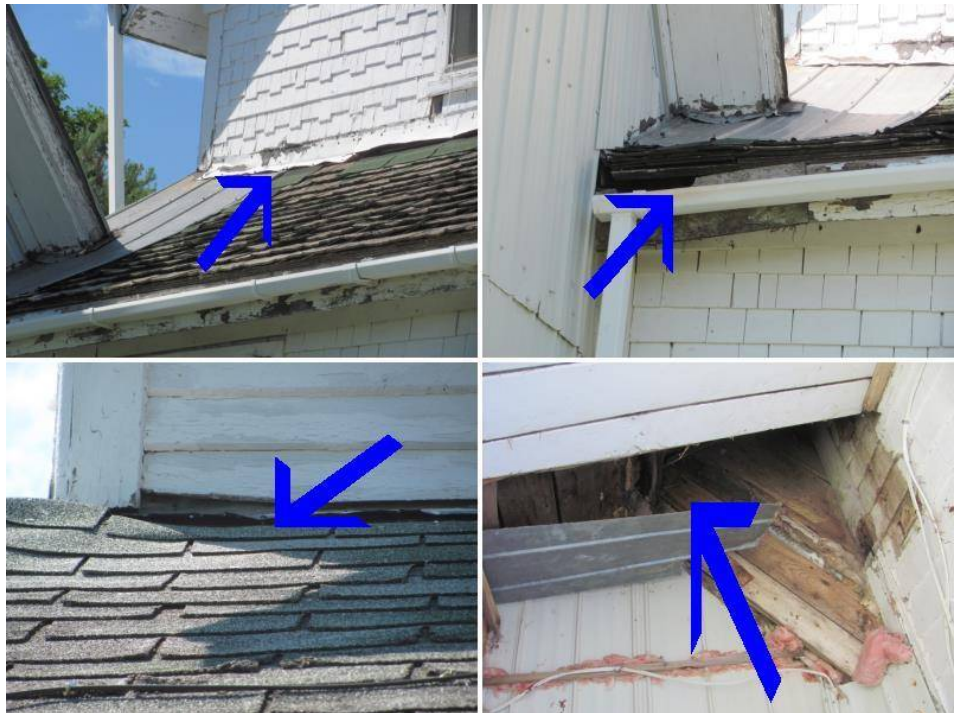
Cover / Roof:

Same as main roof. See Roofing page..... Needs to be replaced--Rot noted.

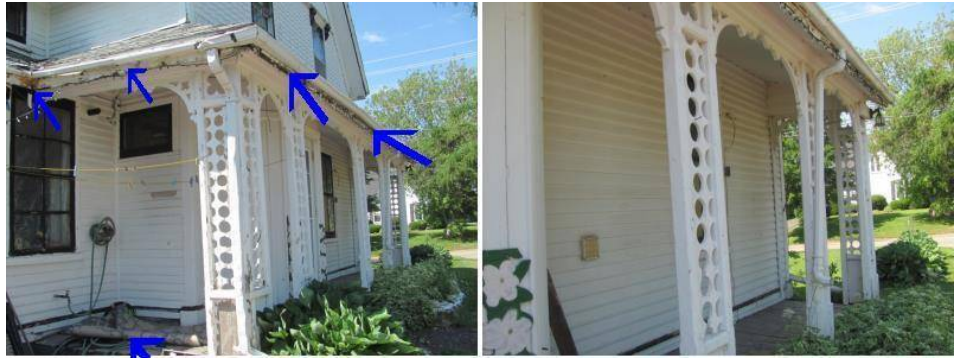
Wrap Veranda Floor

Wood -- Cracks noted - major, Surface raised/settled--Needs repair. Portions missing.

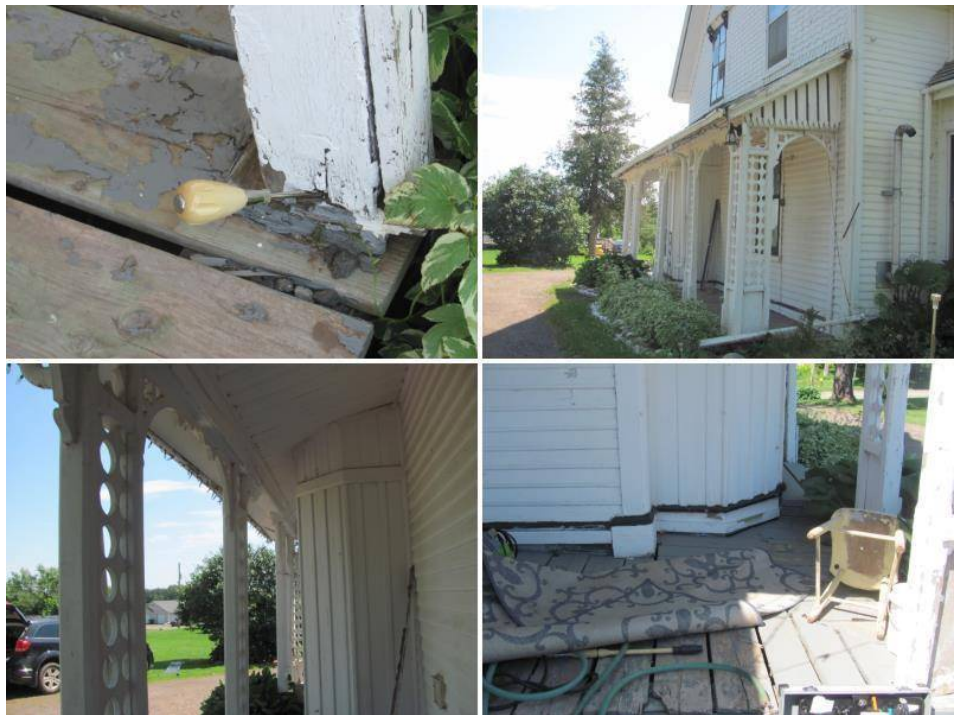
Structure:

Type: Open design Shed roof . **Deterioration noted at base of posts, Needs repair or securing. Noted damaged trims . Structure appears over spanned/sagging/damaged.**

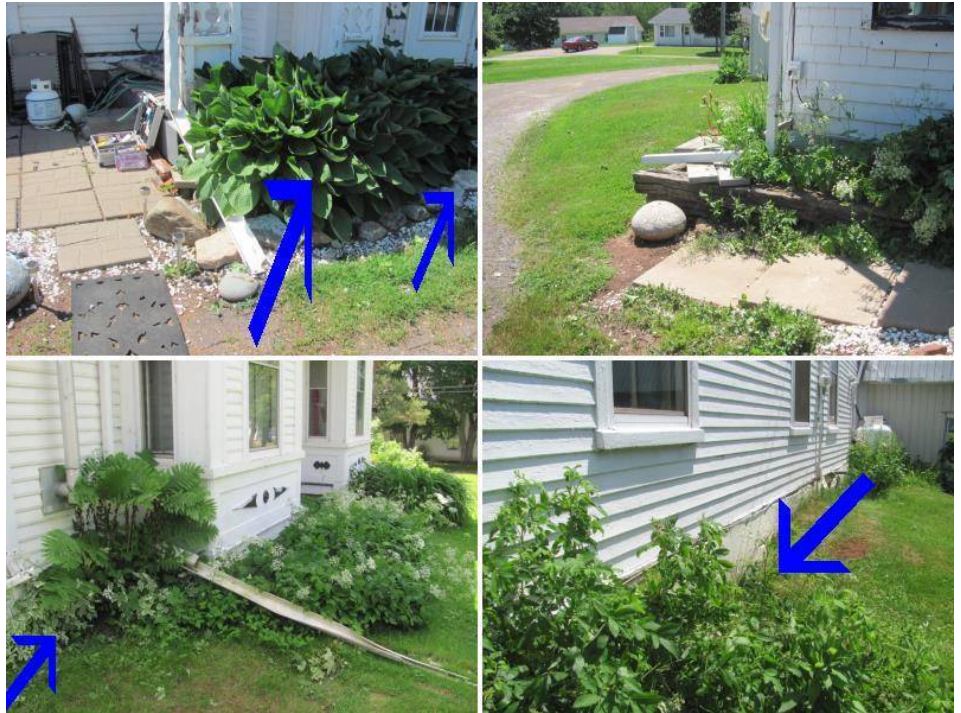
Grading:
Site:

Gentle slope, Grade at foundation is negative in some areas and needs correction Evidence of poor drainage Pitch slope of soils away from foundation. Slope should fall away from the foundation at a minimum of 1/2 inch per foot and extend at least 10 feet away from the foundation, Extend downspouts to divert water away from the house foundation. Splash blocks can be added to eliminate unsightly holes formed by water exiting the gutter downspouts. Lower soil below siding. Grade should be 6 inches below any wood materials, Eliminate earth-to-wood contact.

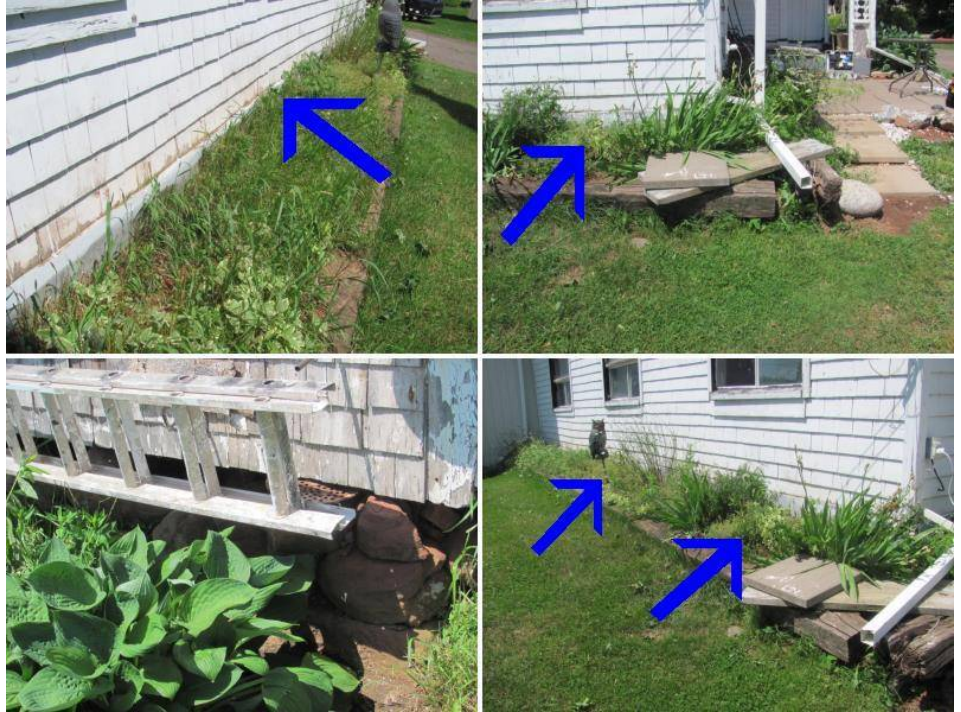
Evidence of poor drainage, Lower soil below siding. Grade should be 6 inches below any wood materials, Eliminate earth-to-wood contact.

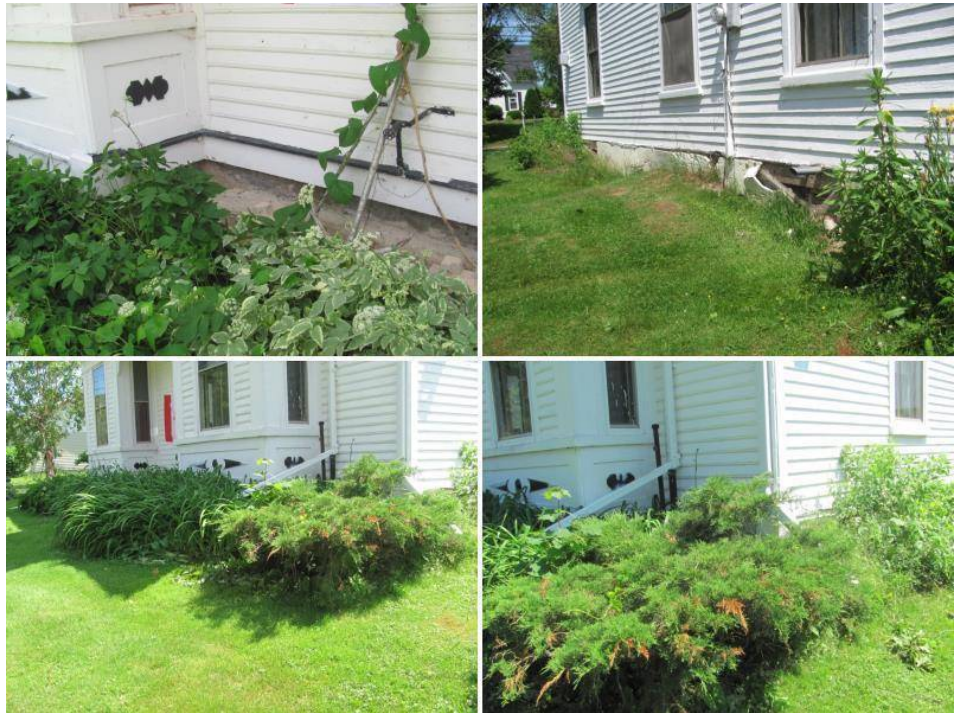
Landscaping:
Condition:

Foliage is overgrown and needs significant trimming.

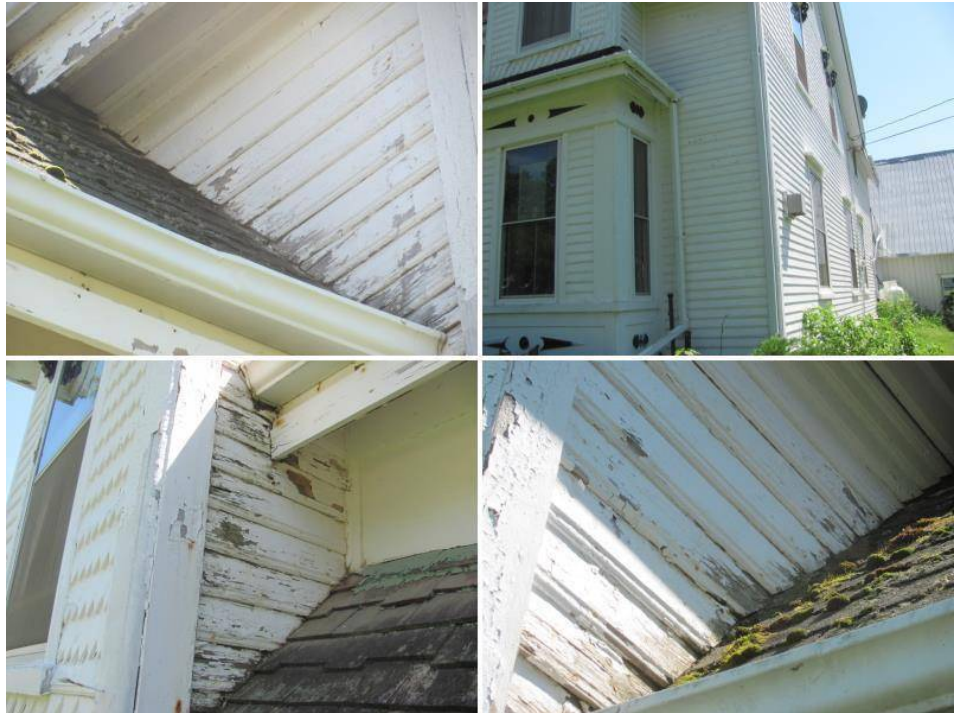
Materials & Condition:

Walls are constructed with Wood siding & Wood Shingles. . Walls are not fully visible due to plan overgrowth. Foliage or vines cover some portions of the exterior.

Cracks noted. **Damaged areas of siding are seen, A qualified trim siding contractor should be called to make further evaluation and repairs as needed.**

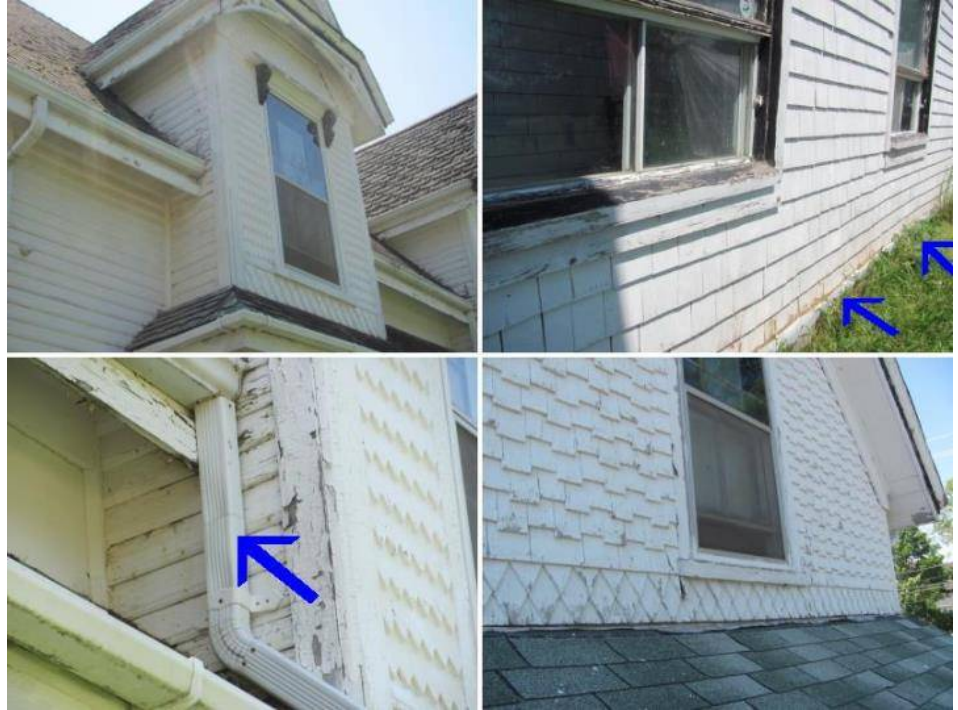
Damaged areas of siding are seen.

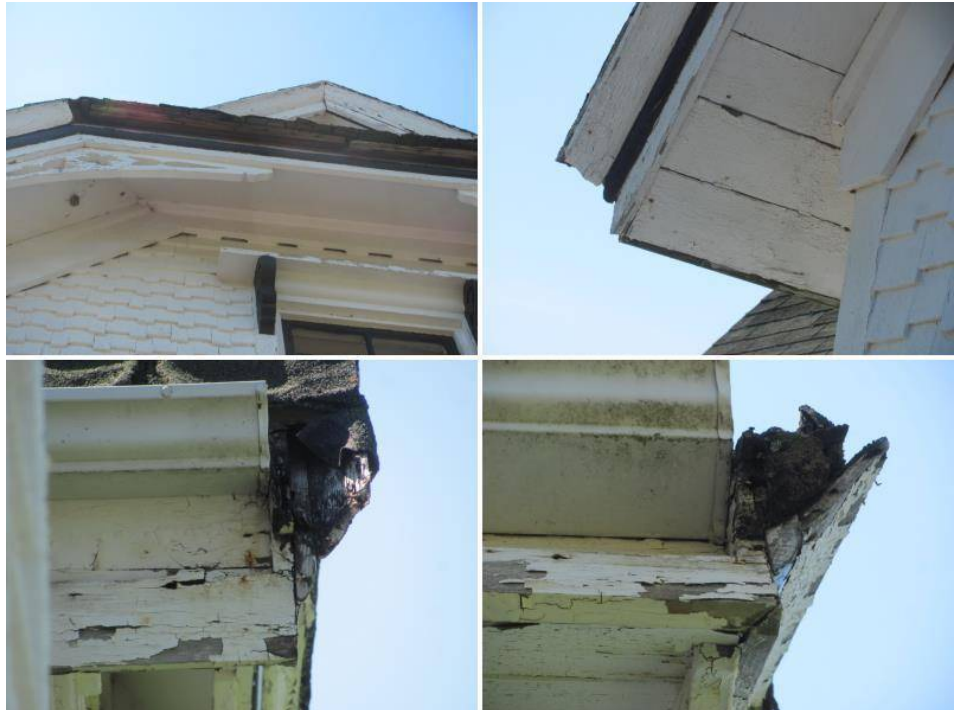
Flashing & Trim:

Wood materials. **Damage noted, Loose or deteriorated material is noted at the trims of the building. Moisture stains/damage noted under eaves, Paint/finish is needed.**

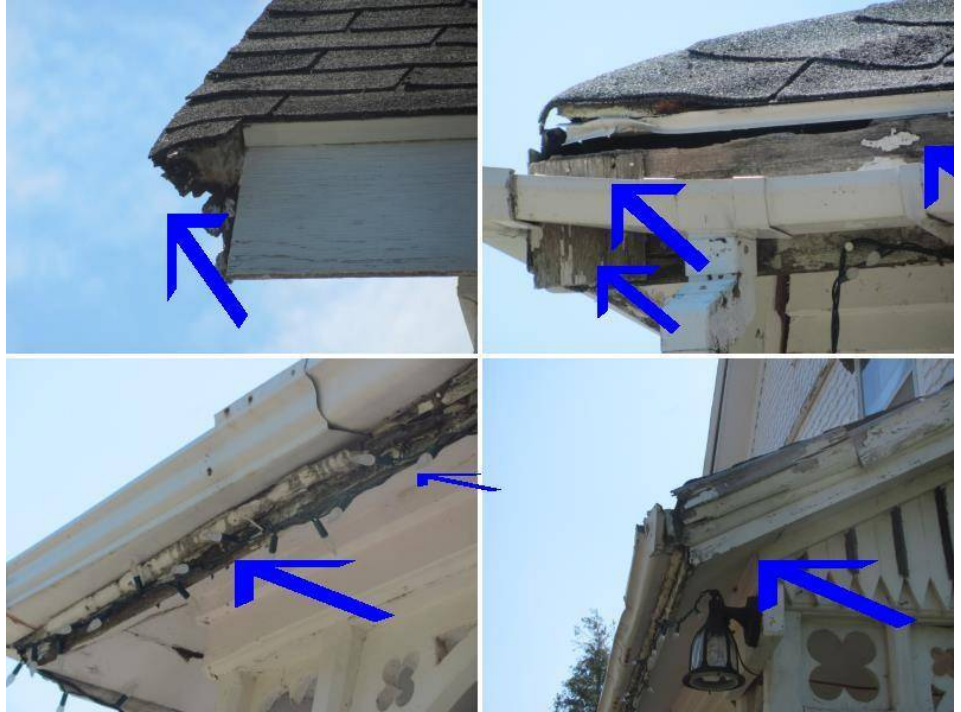
Loose or deteriorated material is noted at the front, back, left side, and right side of the building.

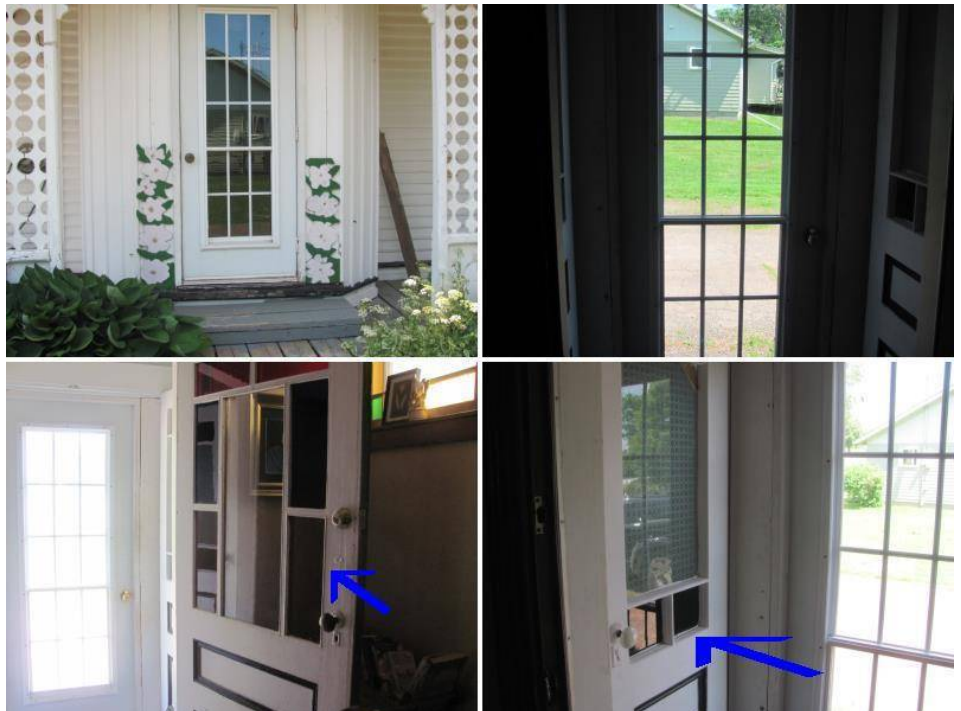
Main Entry Door:

Metal, with glass. Hardware is operational
Original wood door is need of repairs.

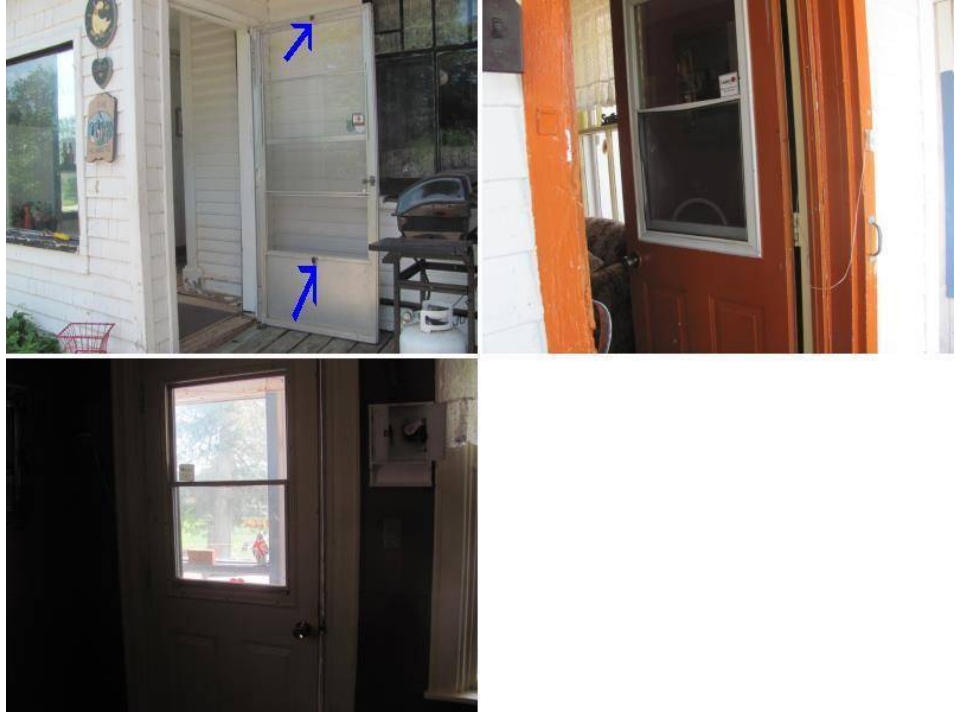
Side Entry Door:

Metal, with glass. Hardware is operational. older unit.
A storm door is present, made of Aluminum. Damage is noted. **A replacement door will eventually be needed.**

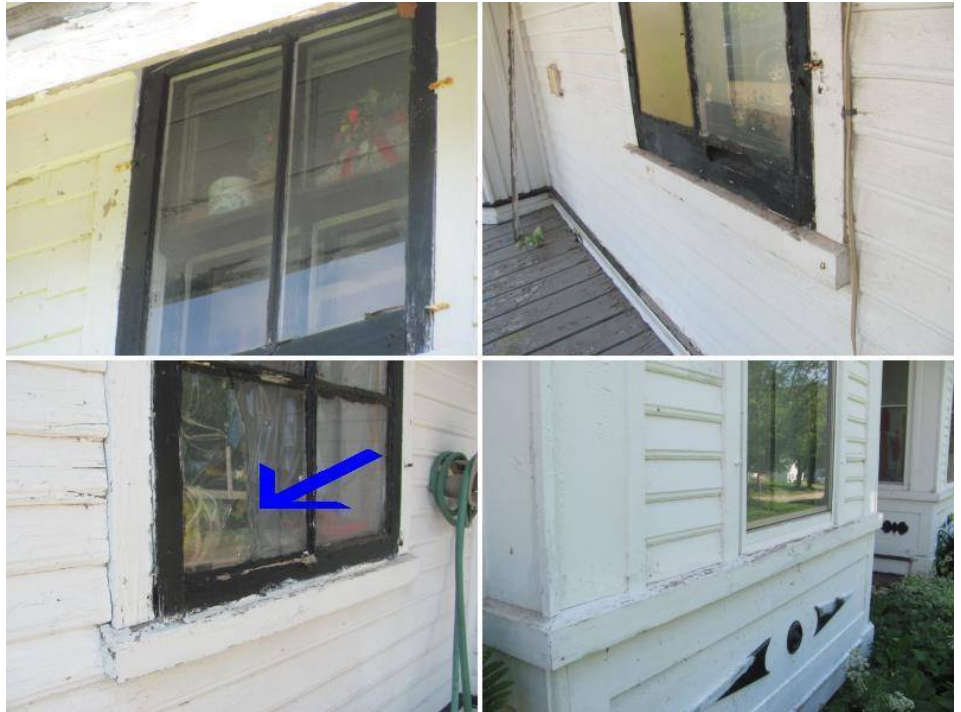
Overall Condition:

Areas of peeling paint are seen. Windows need scraping and repainting to retard ongoing deterioration from the elements. Cracked window panes noted . Some screens are missing..

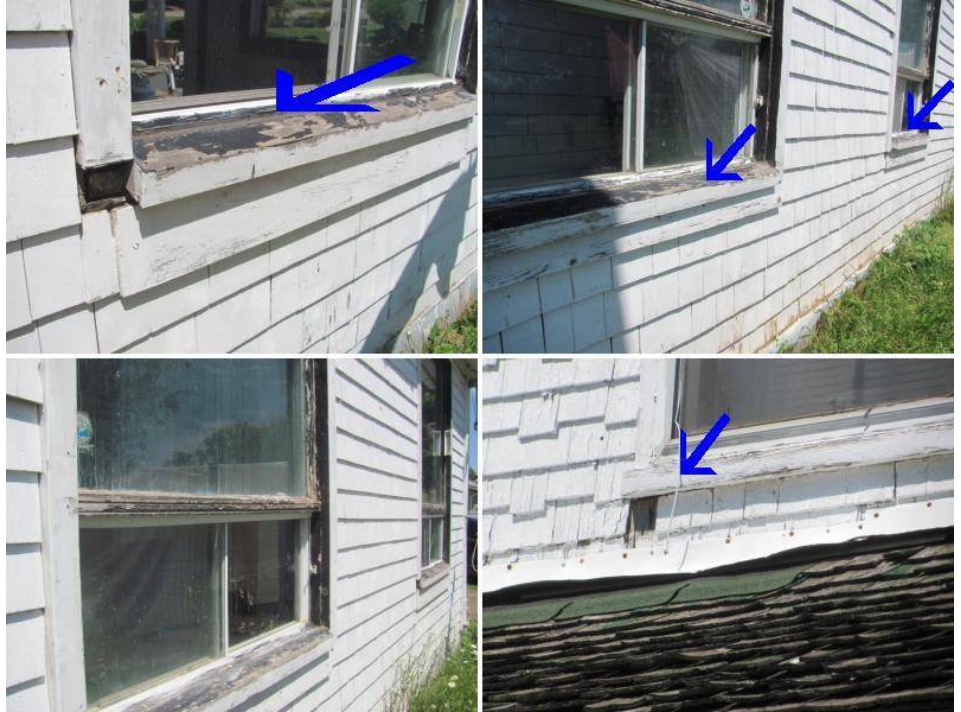
Type And Condition Of Sills:

Wood. **Wood sills have rot due to water penetration. Back porch is the worst.**

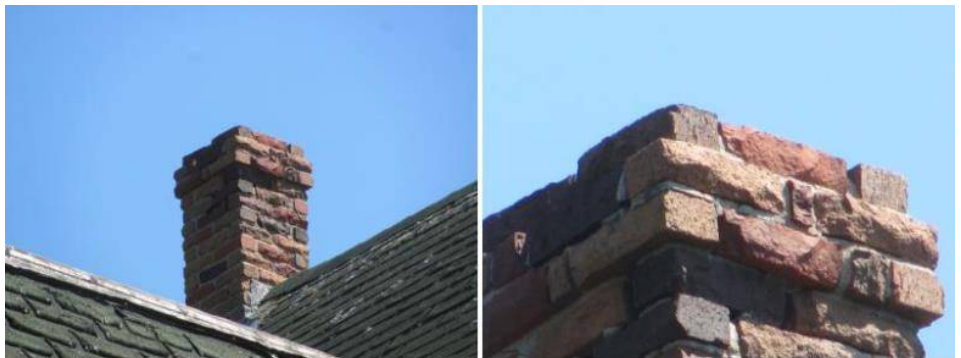
Flue:

The inspection is limited to the visible portions of the fireplace flue.

Recommend repair and further inspection by qualified chimney specialist prior to use.

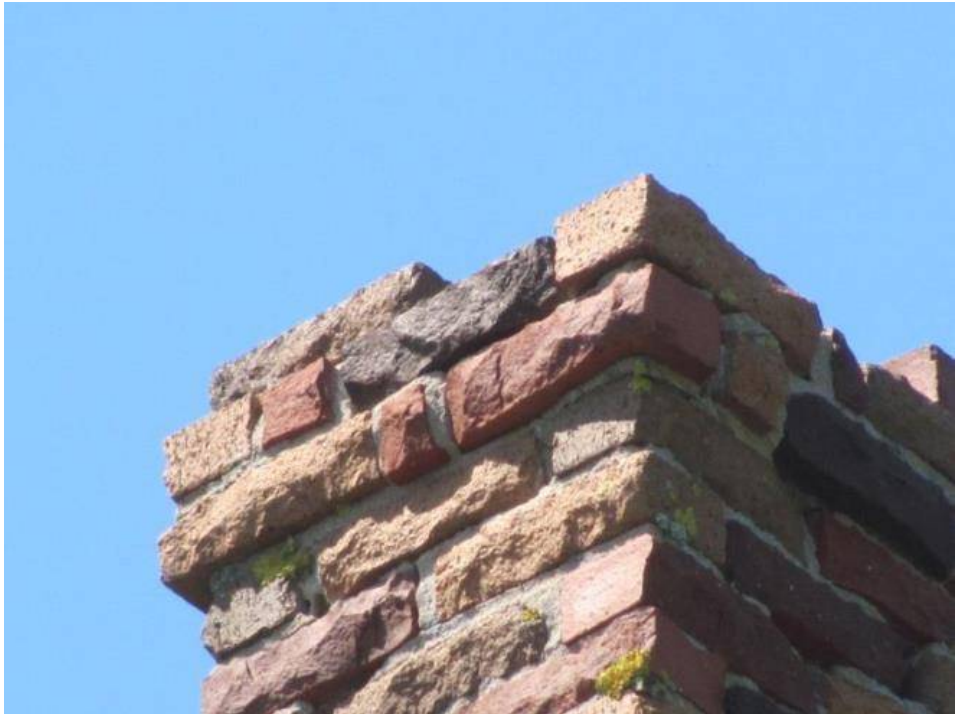
Chimney Cap:

There is no chimney cap installed. Installation of a chimney cap is highly recommended to prevent water from entering the masonry stack or entering the wood chase causing deterioration. There is no metal rain hat installed. It is recommended that one be installed to help prevent rain from entering the flue stack. There is no metal spark arrestor installed. A spark arrestor, in addition to

reducing fire possibility from burning embers, will eliminate animals and birds from entering the flue.

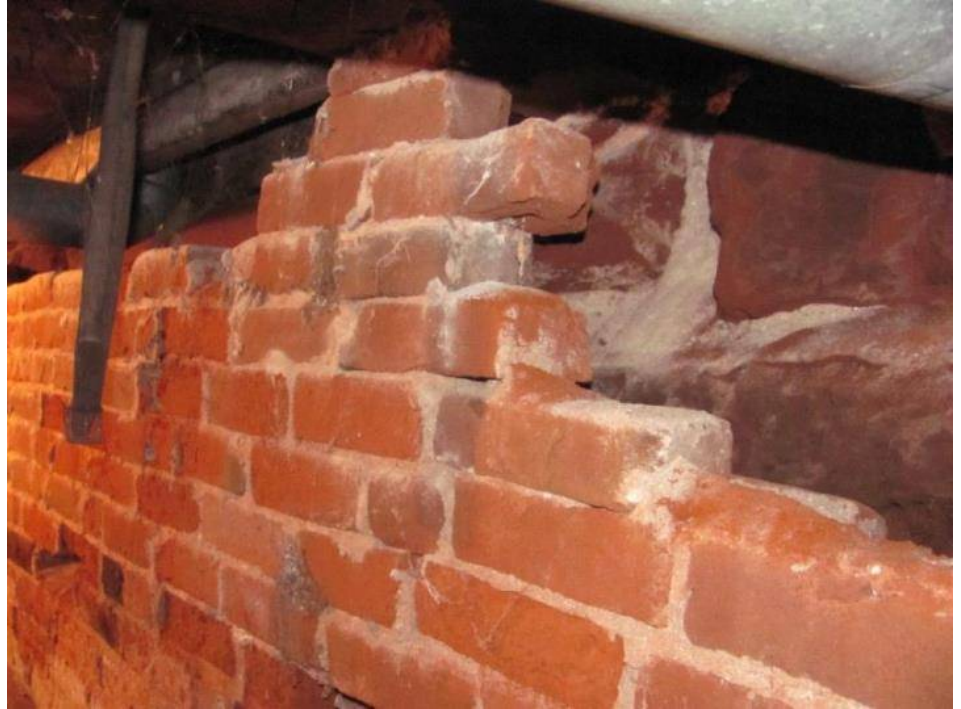
The exposed portions of the perimeter foundation walls need action as there is evidence of failure.(BACK PORCH) + RIGHT SIDE OF HOUSE- (OLD WINDOW WELL) The extent of the damage is not included as a part of this inspection. Further analysis is needed.

Repairs needed.

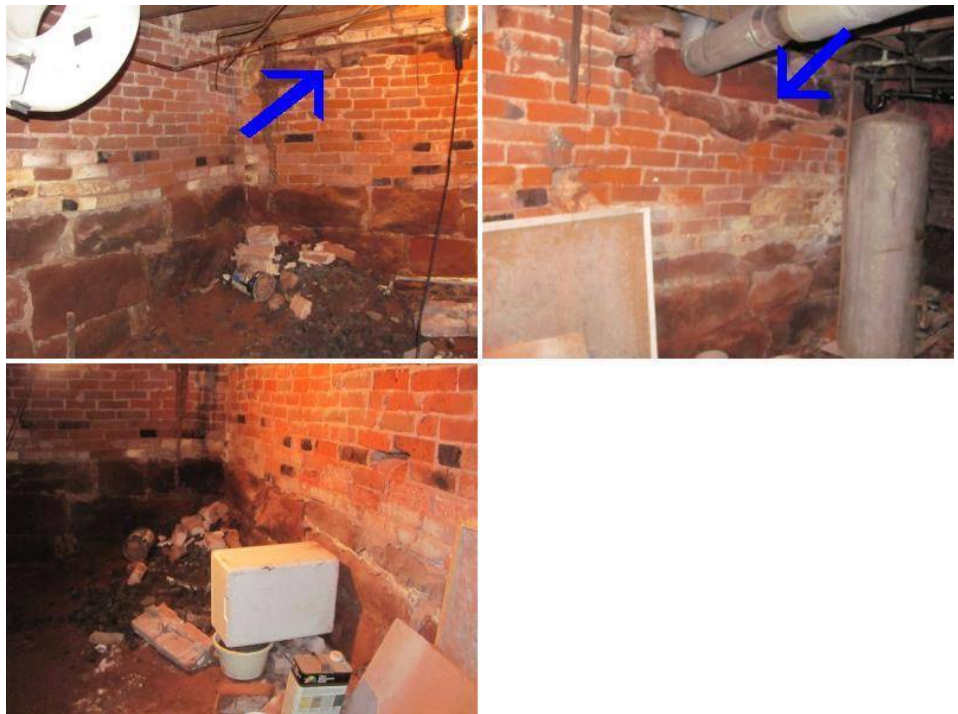
Walls:

Walls are stone. and brick. **Damage/deterioration is noted. The interior exposed foundation walls appear to need repairs . A condition exists that calls for further investigation by a Professional Structural Engineer experienced in foundations.**

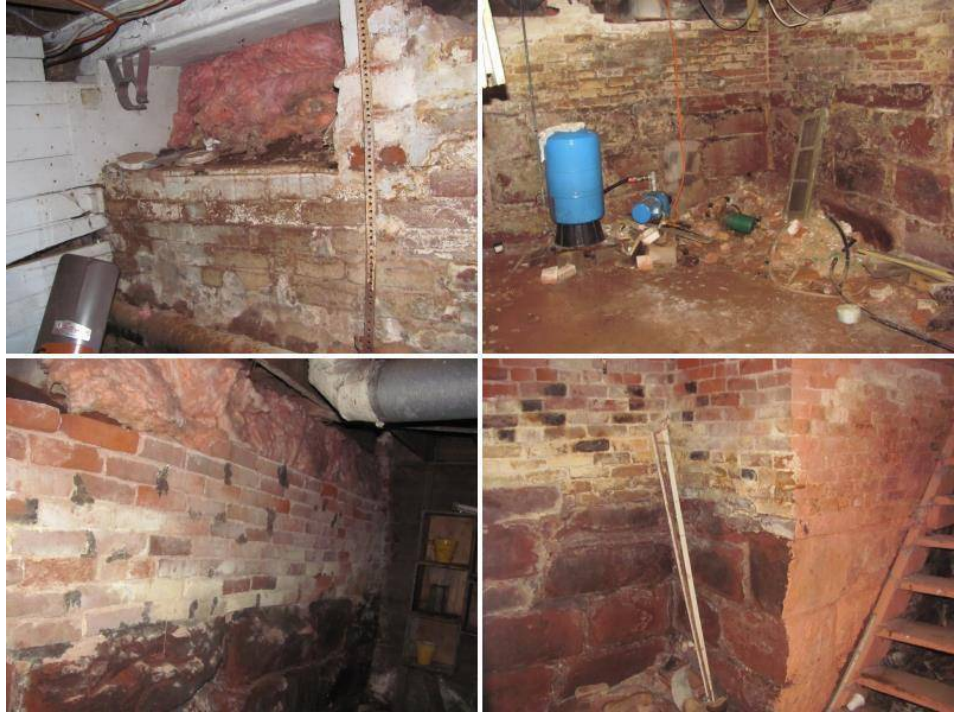
Moisture:

Yes ,normal moisture levels were noted on the exposed areas of the interior basement walls. Staining was observed: Efflorescence seen on walls indicates the presence of periodic moisture. Water seepage may recur in the future. The best defense against water seepage is good drainage of soils near the foundation wall.

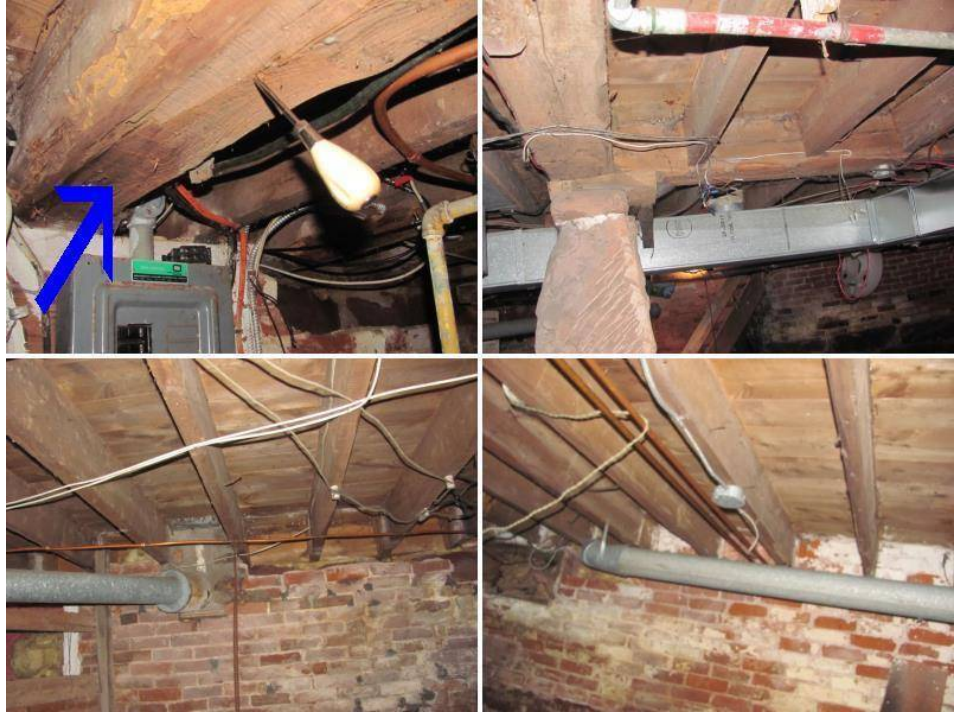
Beams/Underfloor:

Under floor support beams are wood. The main beam is a single large dimension wood board. **Satisfactory NOTED SOME DRY ROT-** - The main beam installed appears to be in satisfactory condition.

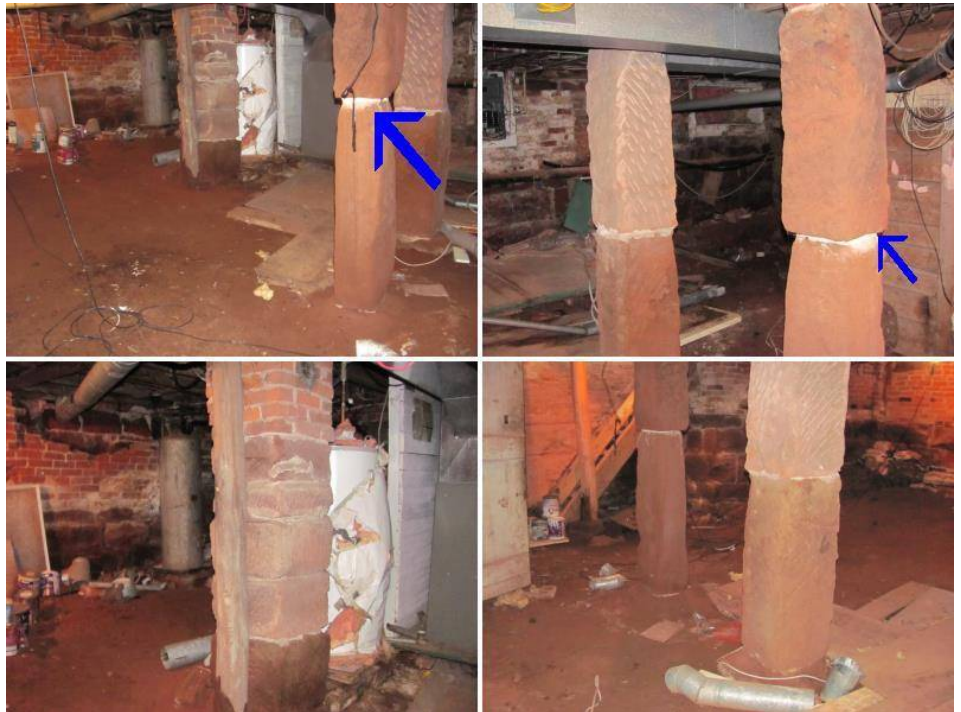
Posts/Piers & Columns:

Support posts are wood., stone, There is soil to wood contact.

This allows a direct path for insects/moisture and should be eliminated. Cracks noted are typical.

Some piers and posts are, out of plumb or weak, The piers as installed appear to need some repair. No engineering analysis was completed. However, a simple visual inspection draws one's attention to inadequacy. Repairs are needed.

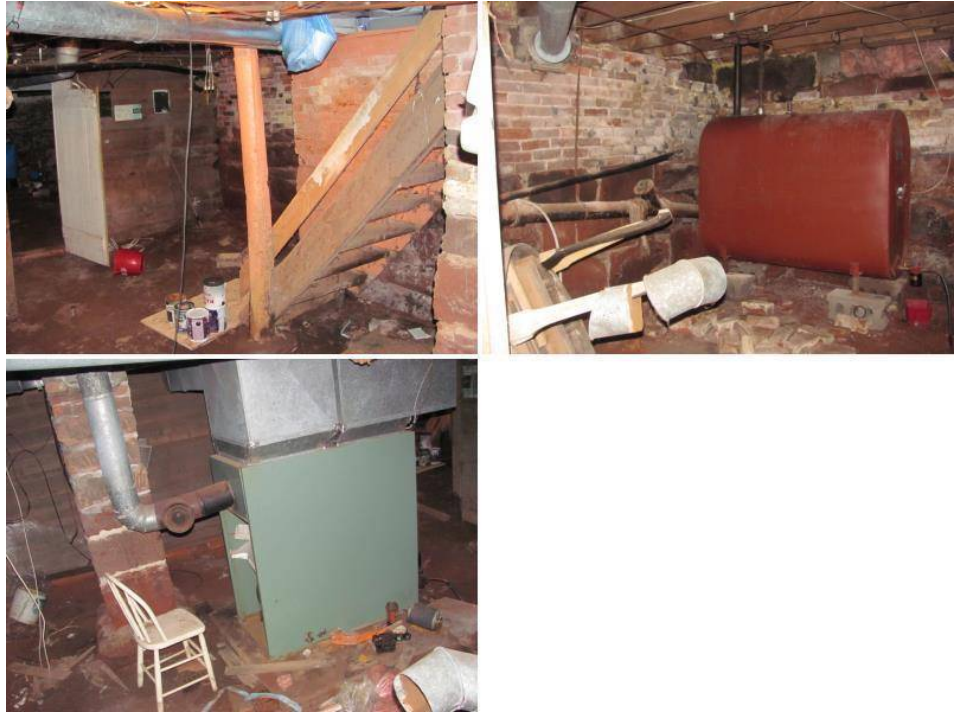
Floor:

Soil, Remove wood debris and trash from the area.
Noted old furnaces and older oil tank.

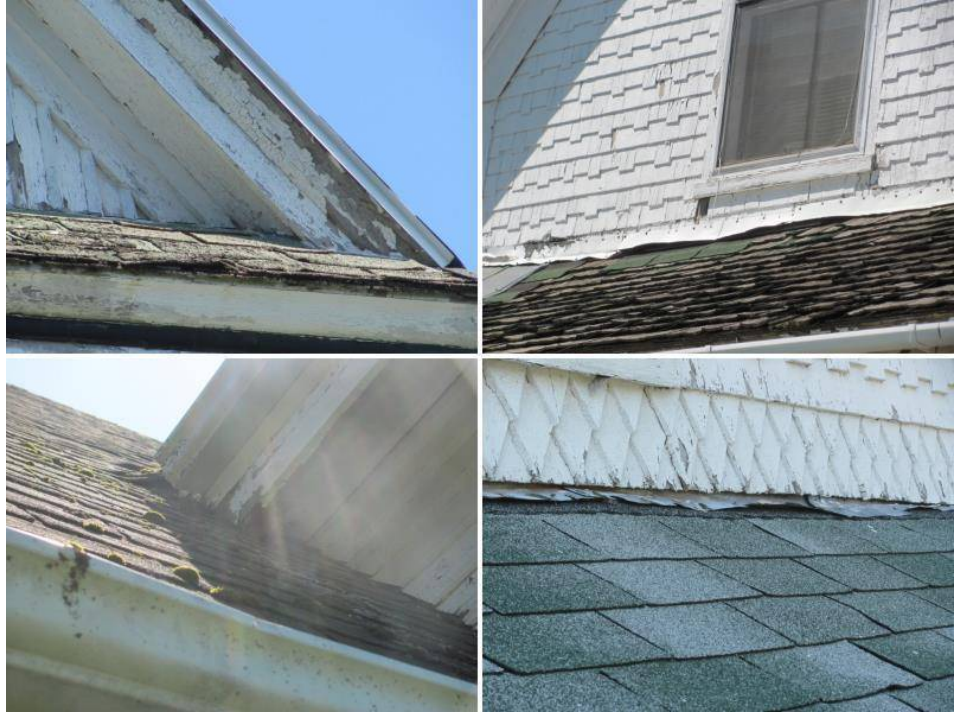
Roof Covering Condition:

Roof is at the end of its normal life expectancy. Roof covering replacement is needed. A licensed roofing contractor should be called to make further evaluation and to provide cost estimates for roof covering replacement. Cracking and clawing of shingles are the result of long term weathering and an advanced shingle age. Felts are showing through, Shingles at the edge of the roof are no longer bonded to underlying shingles. Shingles are subject to damage from wind. This roof is the point in its life where leakage can be expected to occur .over the next few years.

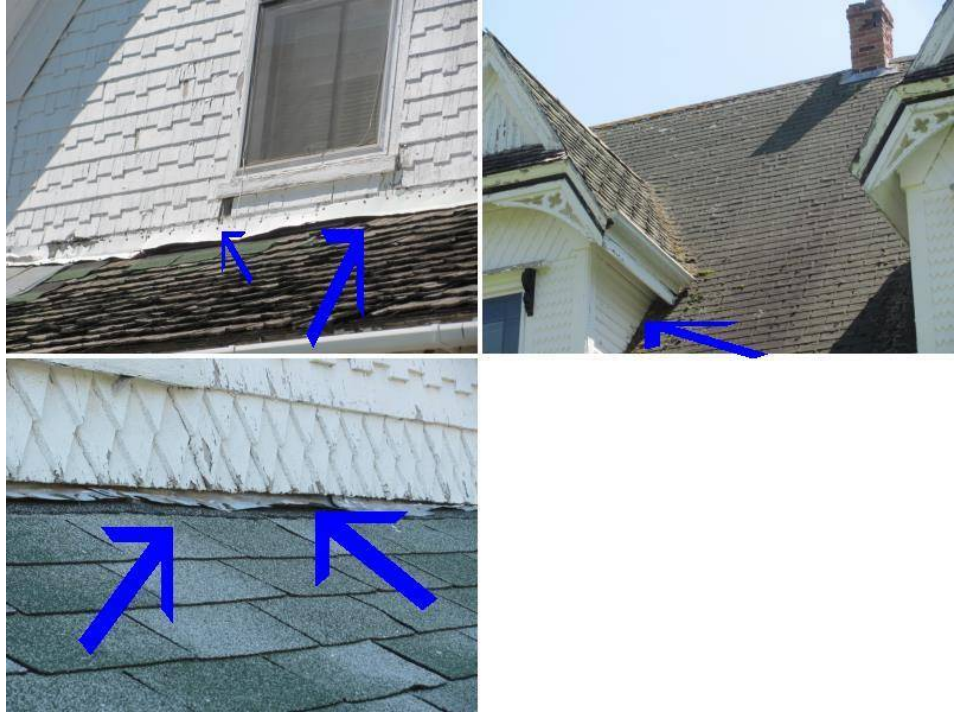
Flashings:

Metal, A potential area of roof leakage is noted- The flashing where the roof intersects with a wall needs some repair or replacement. A licensed roofing contractor should be called to make further evaluation and repairs as needed.

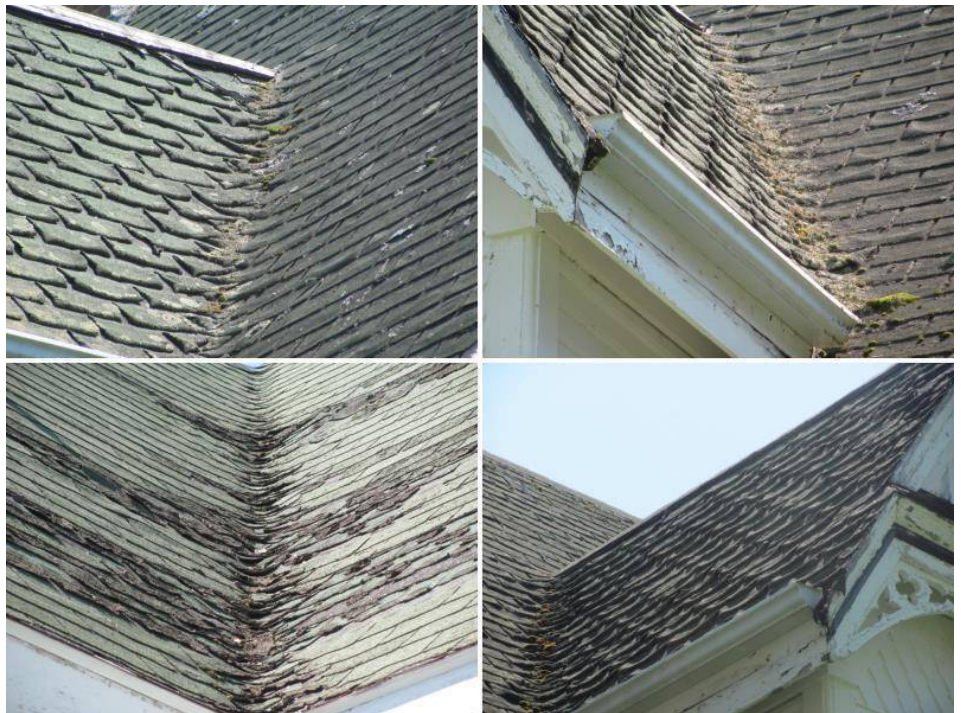
Valleys:

The valley(s) show deterioration that indicates replacement is needed.

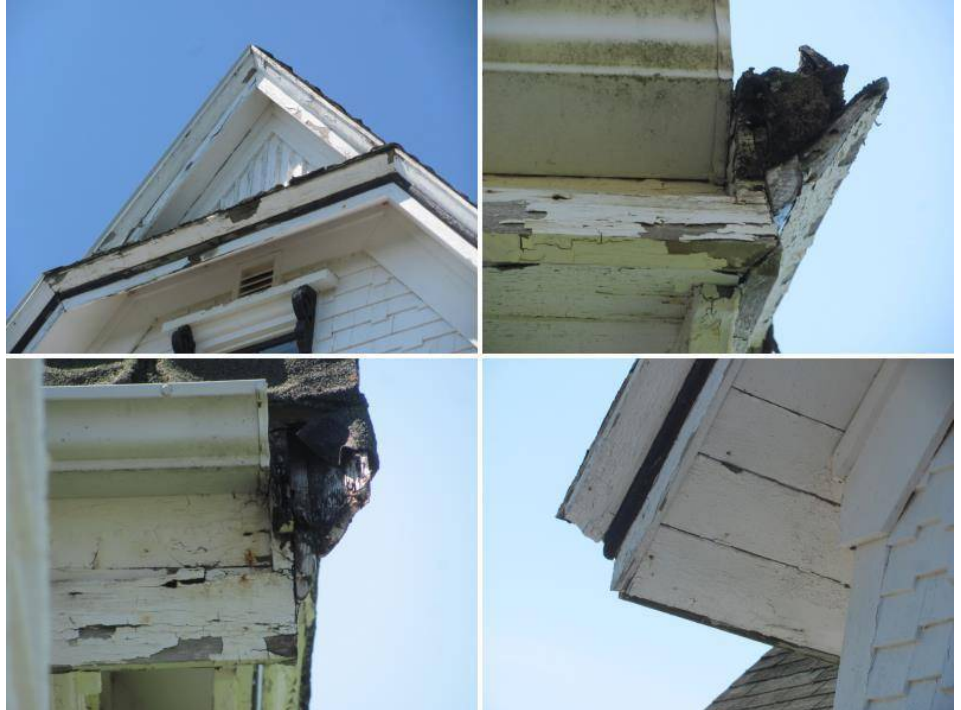
Soffits and overhang materials are wood. Soffits have no venting for the attic.

Deterioration at overhangs noted. Repairs needed to prevent ongoing deterioration.

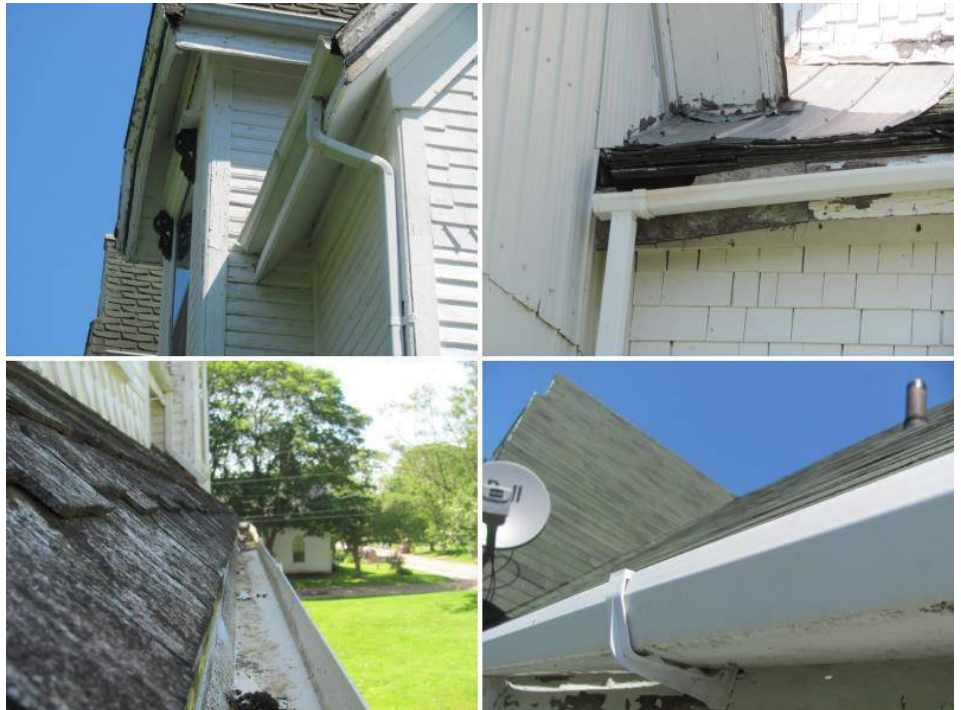
Gutters and downspout materials are plastic. galvanized steel,

Damage/Defects, Missing downspouts noted
Consider installing gutters and downspouts to help with site drainage. Extend downspouts to route rainwater away from the building. Gutters are discharging water near the foundation.

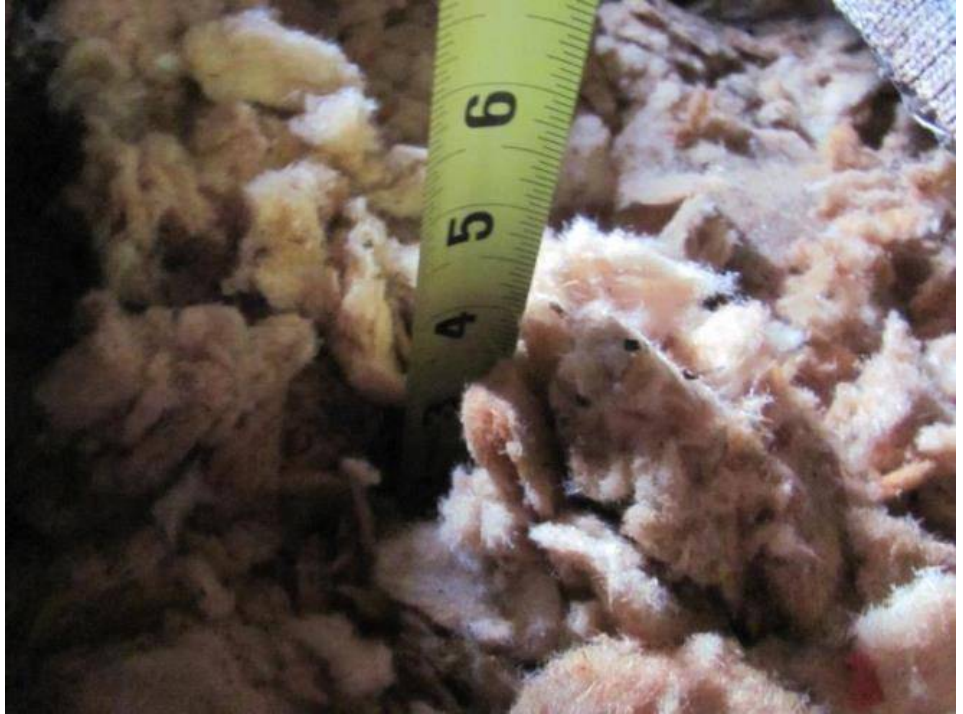
Depth & R-factor:

4-5 inches, R-10 Insulation is somewhat compacted and the true R-factor at this point in time may be substantially less than that originally installed. **Installation of additional insulation is recommended.**

CMHC recommend a R-50 Value.

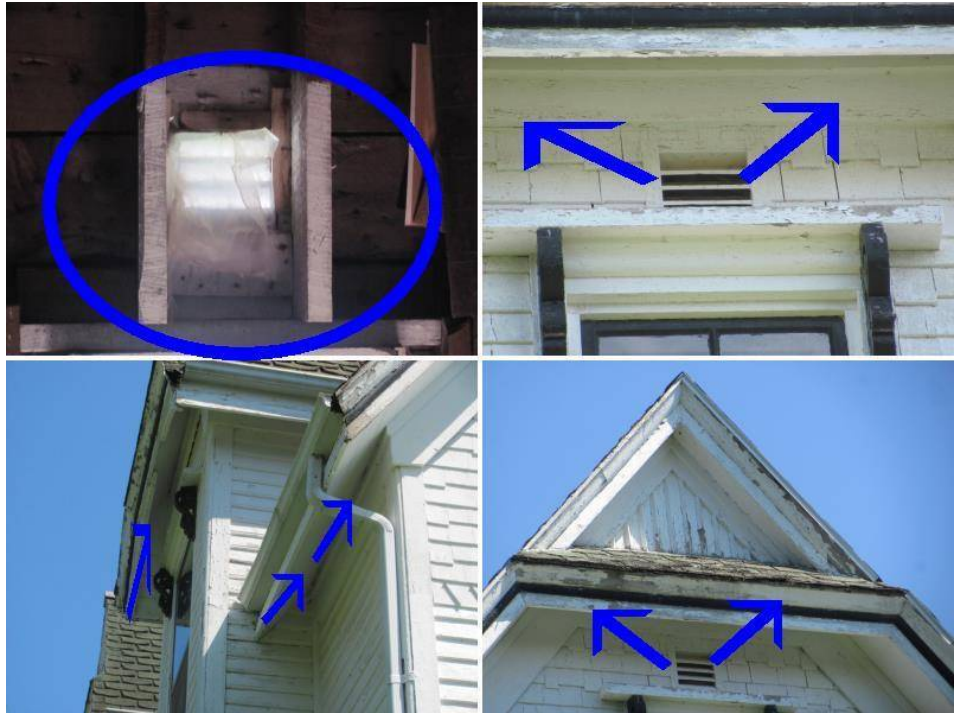
Ventilation Provisions:

There is some ventilation installed; however, the existing venting

does not allow adequate ventilation for the attic cavity. **Action is necessary to correct this shortage of ventilation. Current** industry standards recommend, as a minimum, one square foot of free vent area for each 150 square feet of attic floor if no vapor barrier is installed. With a vapor barrier installed, one square foot of free vent area per 300 square feet of attic space is needed.

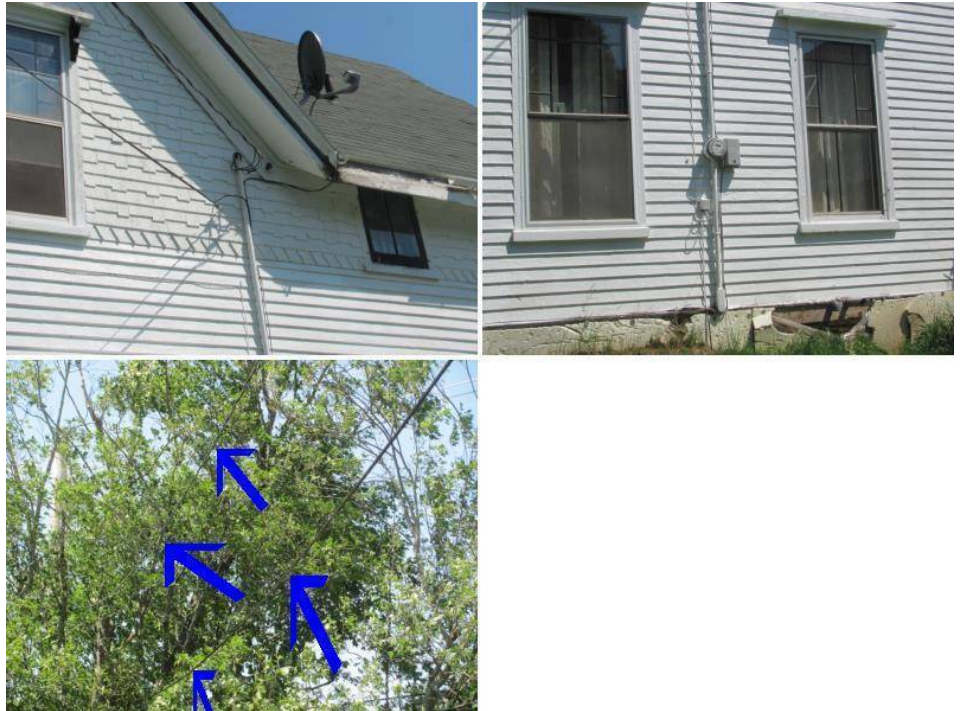
Overhead, Damage/Defects noted: **Overhead conductors are, are contacting tree limbs. Have the power company trim as needed.**
