KENT JACKSON

Confidential Inspection Report

64 TRE # 13
Crapaud, P.E

July 6, 2014

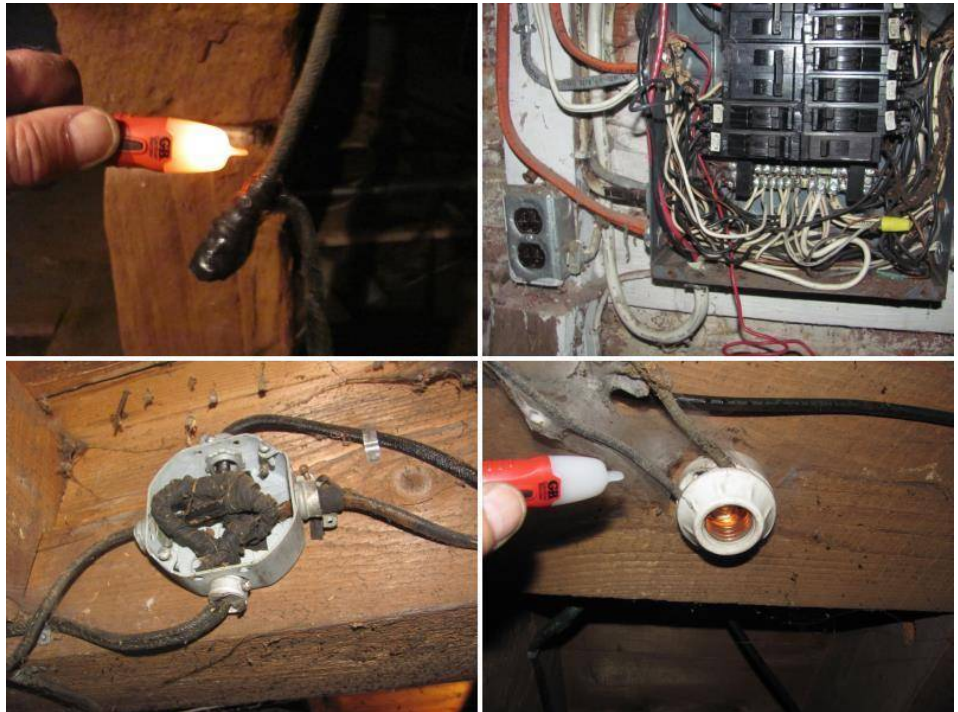
Branch Wiring:

Copper, Damage/Defects noted, Handyman wiring is noted in the following locations: The presence of handyman wiring is an undesirable condition which should be corrected by a licensed electrician. Wiring and connections are often installed in a haphazard manner, with an increased potential for shock, safety and fire hazards. The installer may be familiar with particular precautions which he/she has grown accustomed to taking when operating equipment powered with such wiring, but as a purchaser, you or your family may not be. One of the most common problems is the use of inappropriate wire in exterior or damp locations. Doubling up of wires on circuit breakers and incorrect routing and

attachment of wires, along with incorrect wiring of fans are other often seen occurrences. Costs for correcting wiring of this type can accumulate rapidly, as correction of one deficiency sometimes uncovers the existence of another. Every instance of handyman wiring present may not be detailed in this report. Electrical wiring junctions not contained within covered electrical junction boxes are a FIRE HAZARD, Where electrical wires join each other in areas other than within a closed electrical junction box, a fire hazard exists. Overheating at any exposed wiring junctions could cause a fire which would spread quickly throughout the house. Electrical junction boxes with covers are used to contain any overheating which may rarely occur. Each of the above areas where uncontained electrical junctions occur should have an electrical junction box and cover installed. A licensed electrician should be called out to add these boxes as needed. Cost is likely to be minimal. Improperly terminated or exposed wiring is found-

Unsafe conditions exist
Some abandoned or disconnected wiring is found.

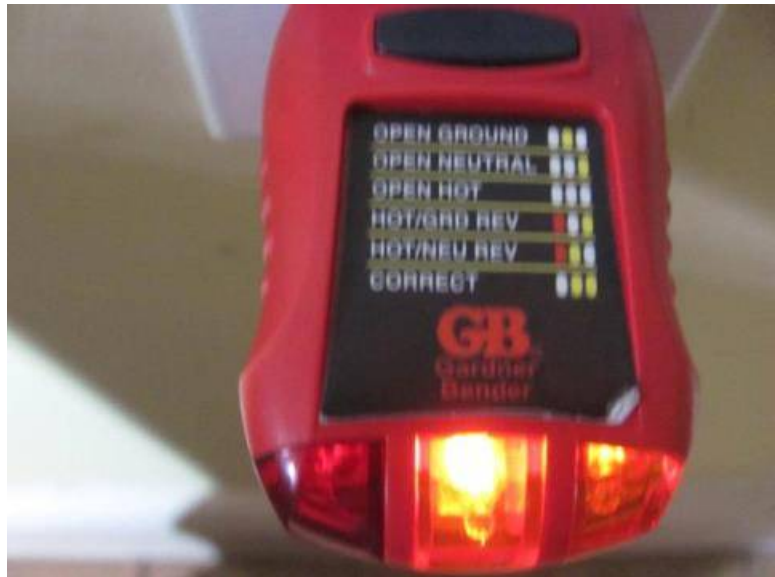
General:

Improper wiring is noted, Recommend exposed wiring be properly protected, Junction box cover(s) are missing, NOTED THE PLUGS ON MAIN LIVING FLOOR WILL NEED TO BE CHECKED FOR PROPER GROUNDS.

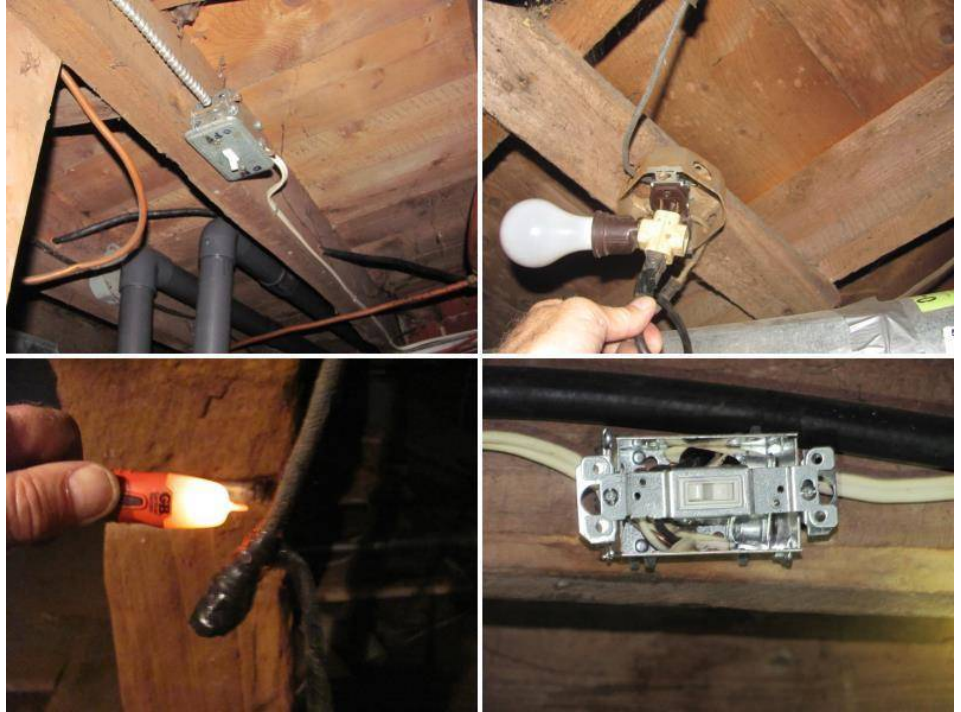
Basement:

Stored items prevent access and testing at some outlets and switches.--- **Improper wiring is noted, Recommend exposed wiring be properly protected, Exposed splices are noted, Junction box cover(s) are missing.**

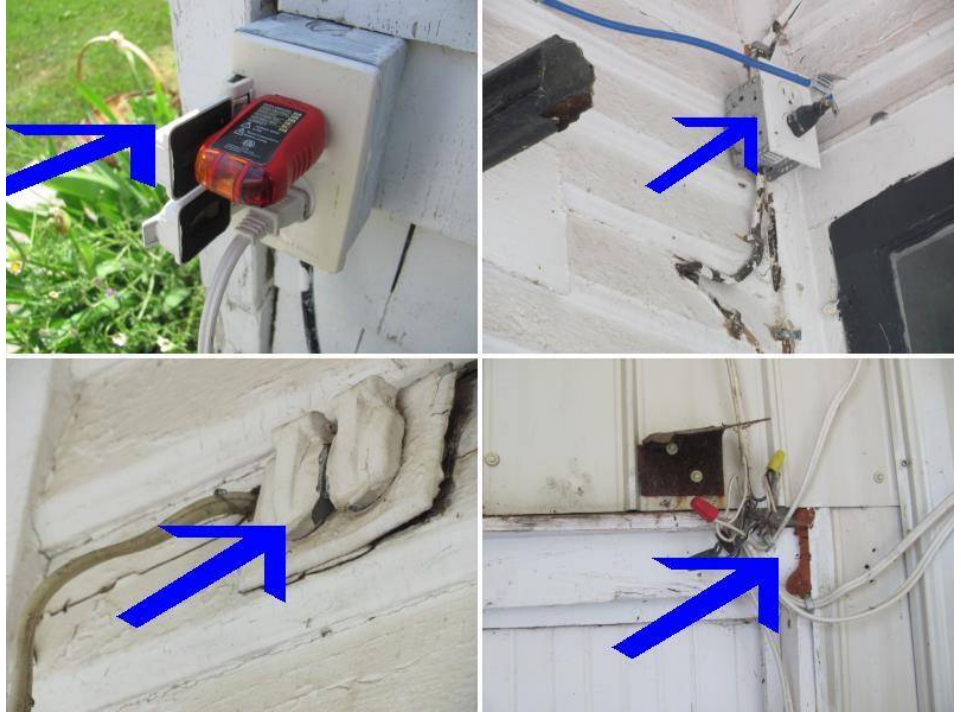
Exterior Walls:

Some grounded 3 hole outlets were not properly grounded. Inoperative electrical outlet noted, A tired outlet was noted. The outlets ability to hold the plug in place is lacking. Replacement of the outlet receptacle is needed.

Ground Fault Circuit Interrupter (GFCI) outlets are recommended for installation at exterior or basement locations.

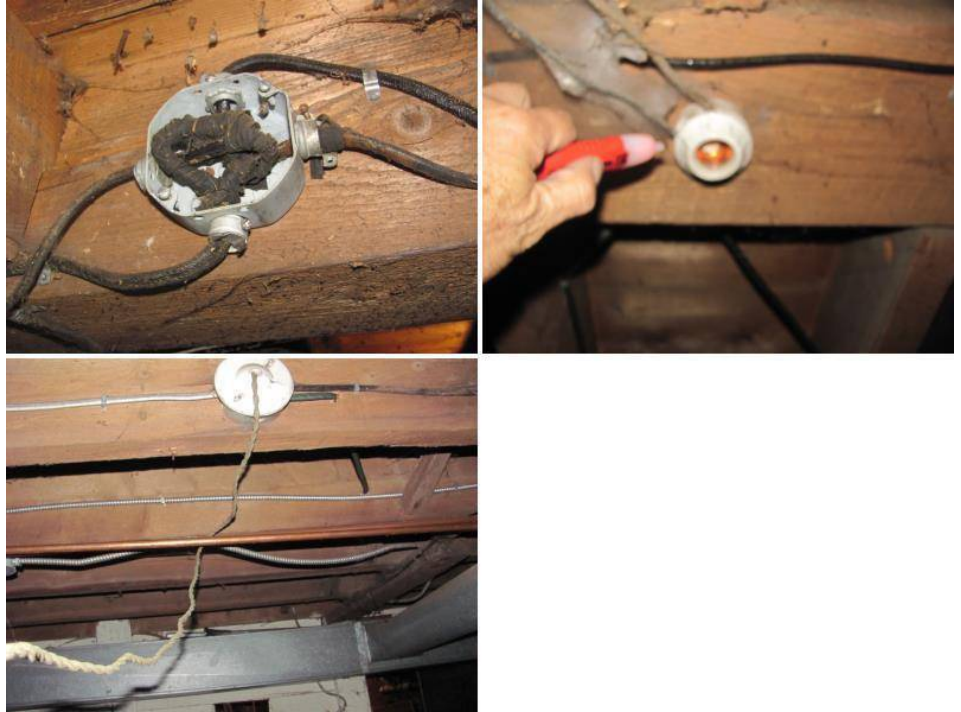
Basement:

Ground Fault Circuit Interrupter (GFCI) outlets are recommended for installation at exterior or basement locations. **Some outlets did not function, Stored items prevent access and testing at some outlets and switches. Missing or damaged cover plates viewed, At some time the electrical outlets have been upgraded from the original 2-prong outlets to modern 3-prong outlets without upgrading the wiring to the outlets. This presents an unsafe condition. The purpose of the third prong is grounding. It is the alternate path for the electrons to flow back to the main electrical panel. If there should be a short, the electrons do not have an alternate path back to the electrical panel without the grounding wire. There is a serious potential for electrical shock that could result in injury or death. Services of a Qualified Professional Electrician are needed. A tired outlet was noted. This means the retention ability is lacking. A plug can slide out of the socket and create a spark on the way out creating the potential for fire. Replacement of the outlet receptacle is needed.**

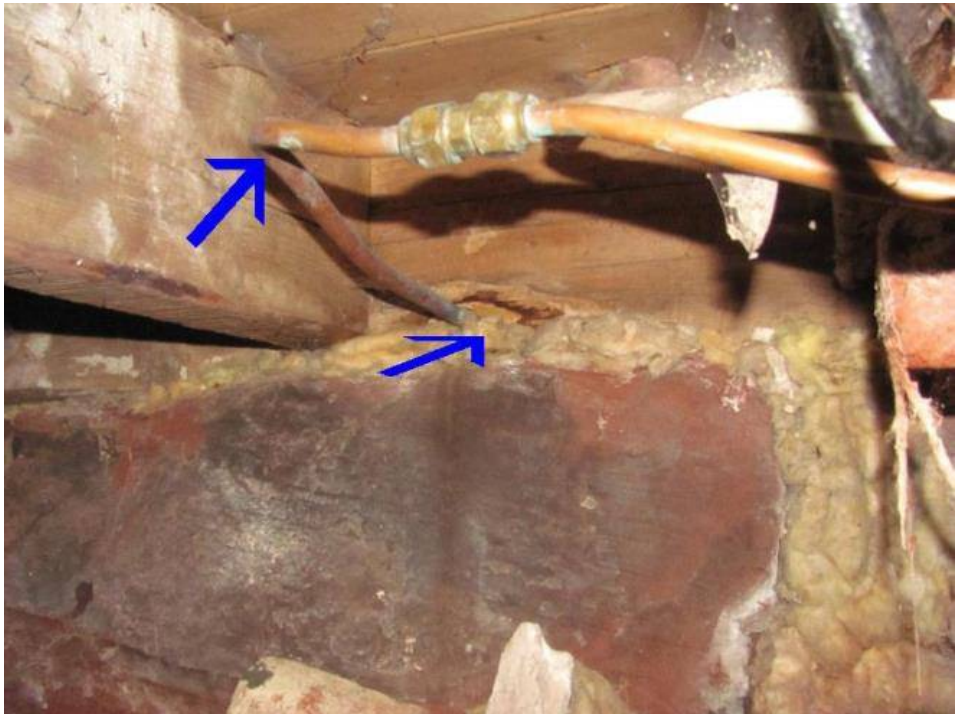
Propane. **Pipes are subject to damage where they enter through basement wall.**

Piping lacks adequate support, **Pipes and valves are subject to damage.**

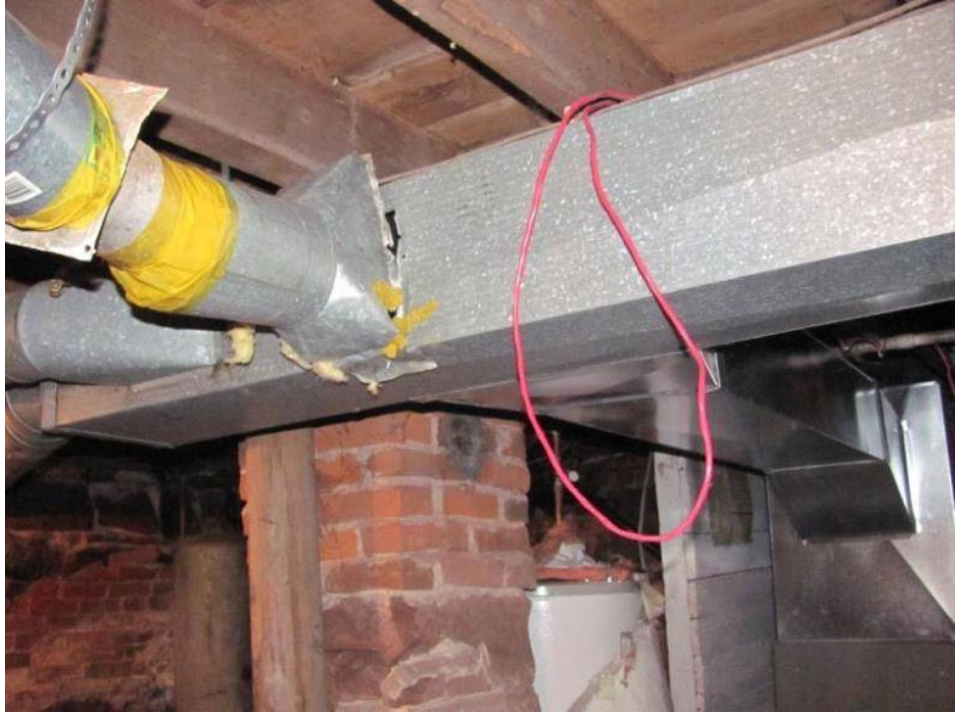
Normal Controls:

Metal pipes AIR LEAKAGE- Re taping is needed.

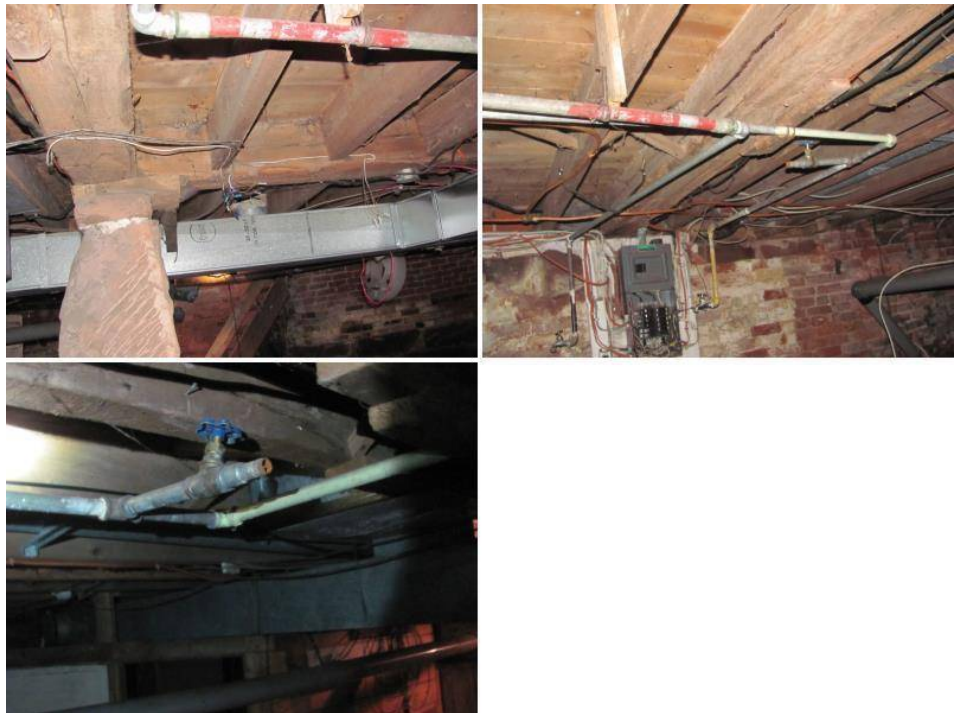
Condition:

Minor corrosion is noted, No leakage is noted, but monitor in the
future, Copper/Galvanized piping contact is noted. Correction is
recommend. Defects noted.

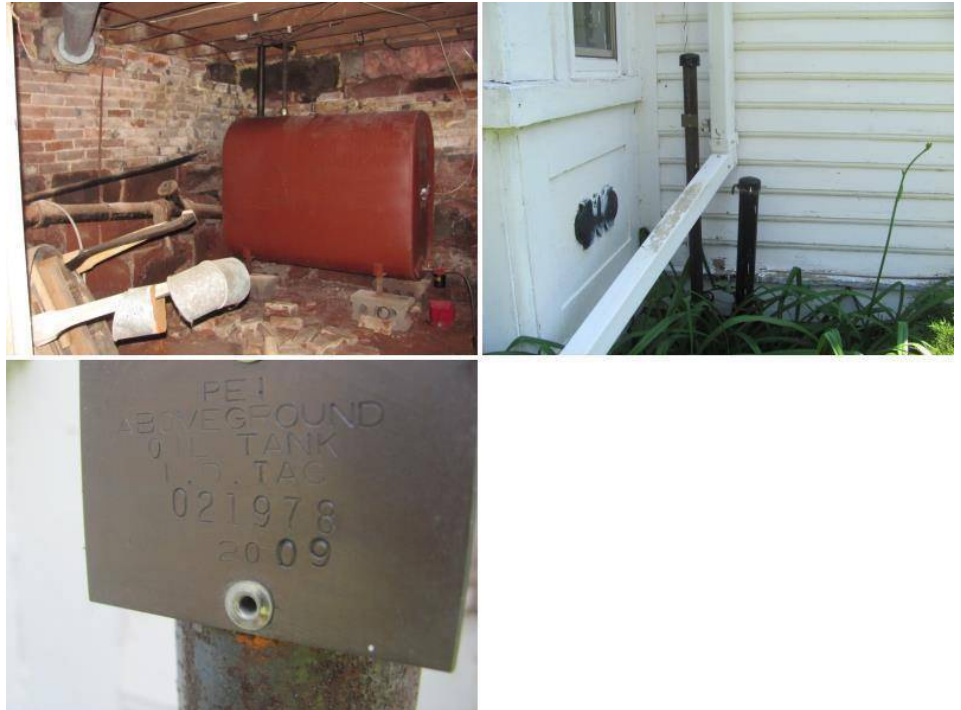
Meter / Tank:

Oil tank is located in Basement---**told this was not in use. Lines not corrosion proofed--outdated.**

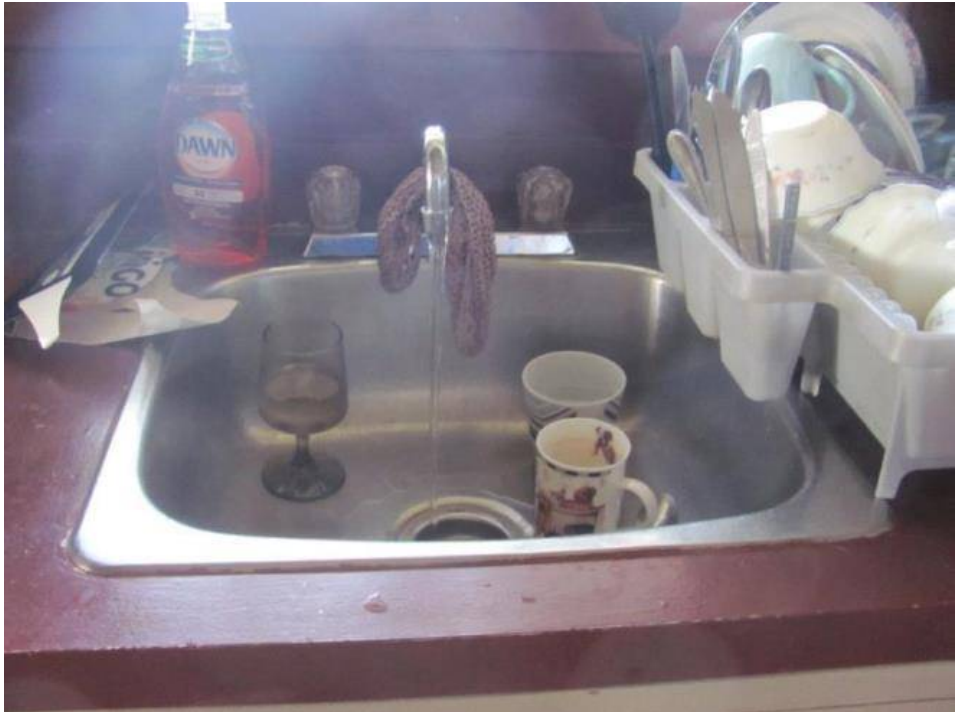
Kitchen Sink:

Stainless Steel, Faucet is serviceable, Heavy wear/chipped,

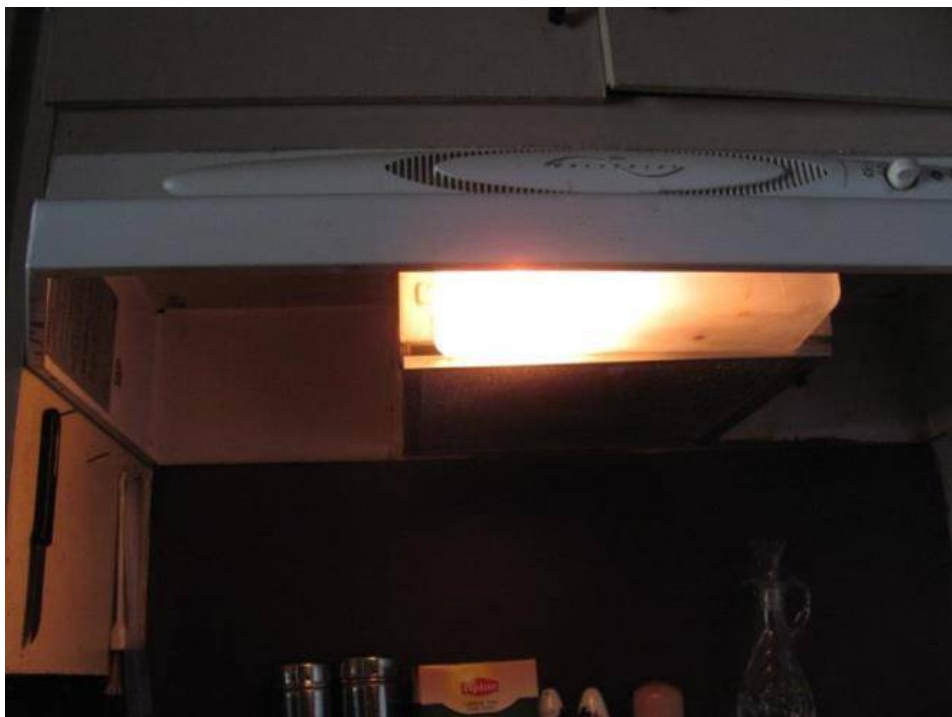
Exhaust fan is noisy.

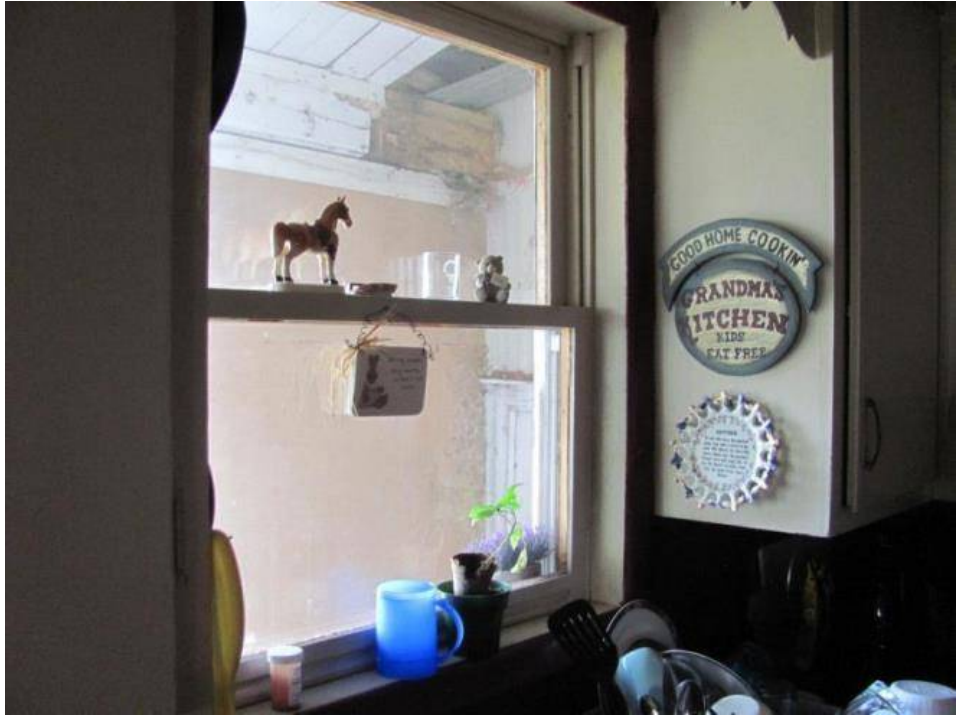
Kitchen Interior:

Needs some repairs.

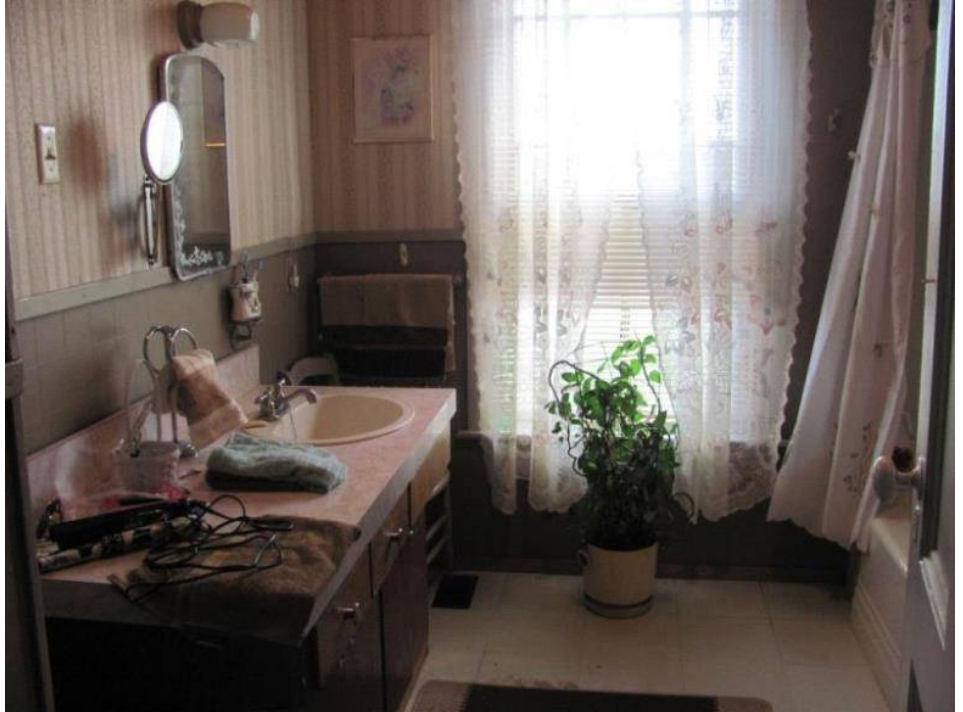
*Bath Between Bedrooms:
Upstairs.*

Needs some repairs.

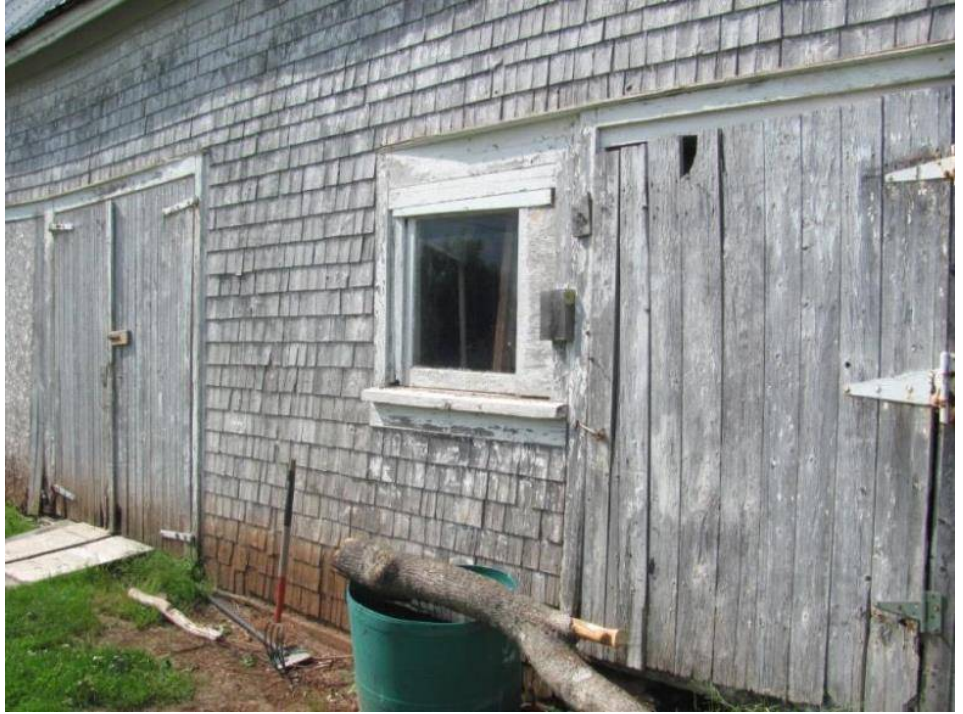
Damage is noted.

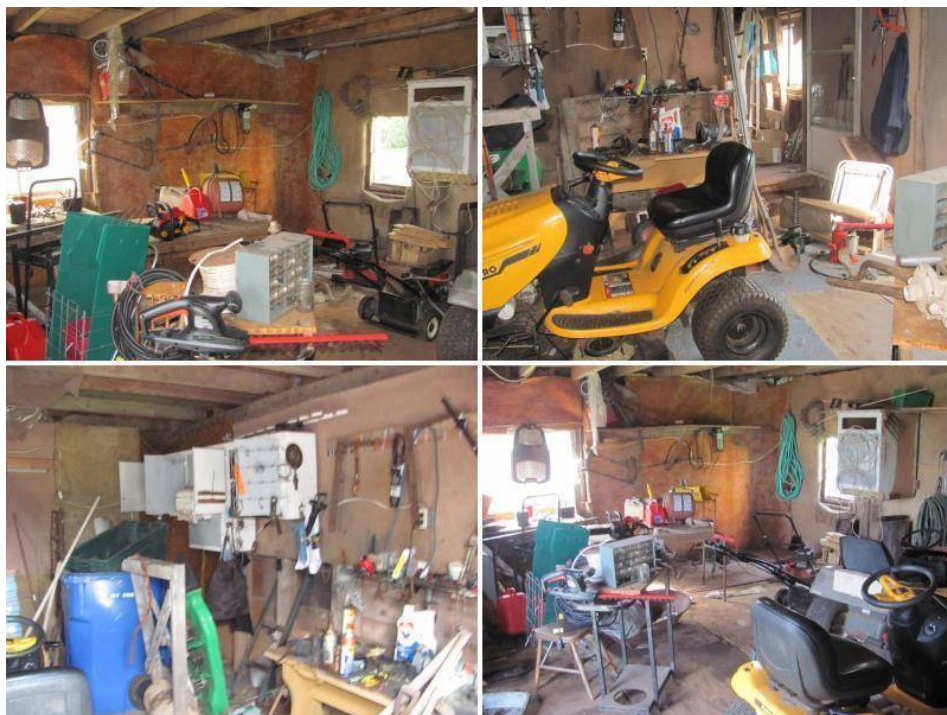
Major cracks noted, Repairs Needed, Floor is not fully visible, due to stored items.
