KENT JACKSON

Confidential Inspection Report

64 TRE # 13
Crapaud, P.E

July 6, 2014

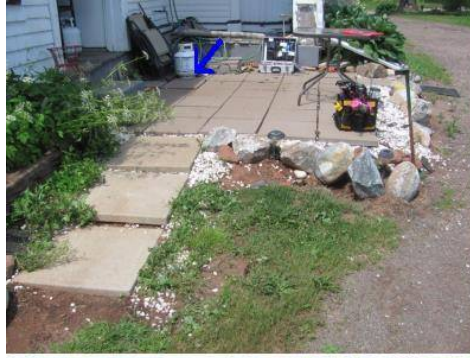
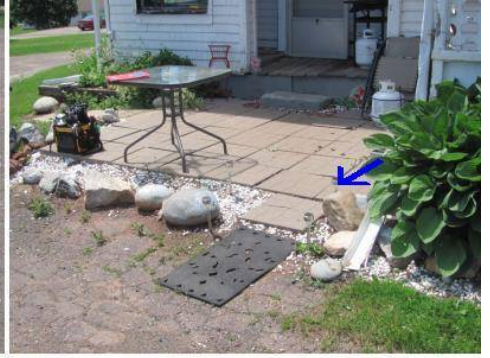
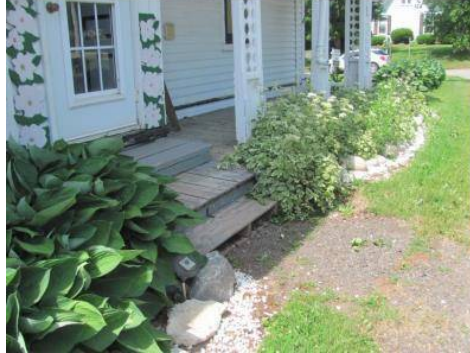
Walks:

Sidewalk type: Concrete, Paver/Tile, Cracks noted , Repair needed Surface raised/settled.

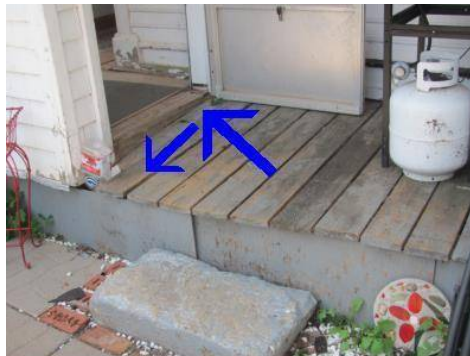
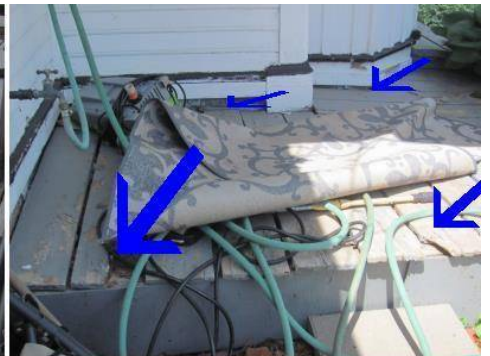
Exterior Steps / Landing

Loose Step(s) **Noted damage --suggest replacement.**

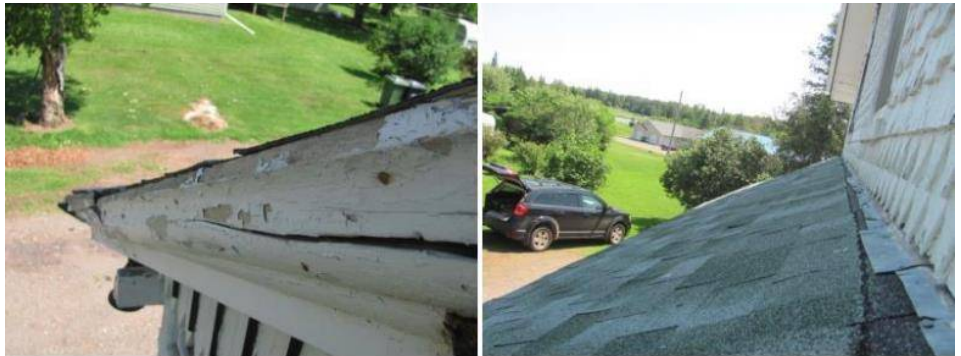
Cover / Roof:

Same as main roof. See Roofing page. **Needs to be replaced.**

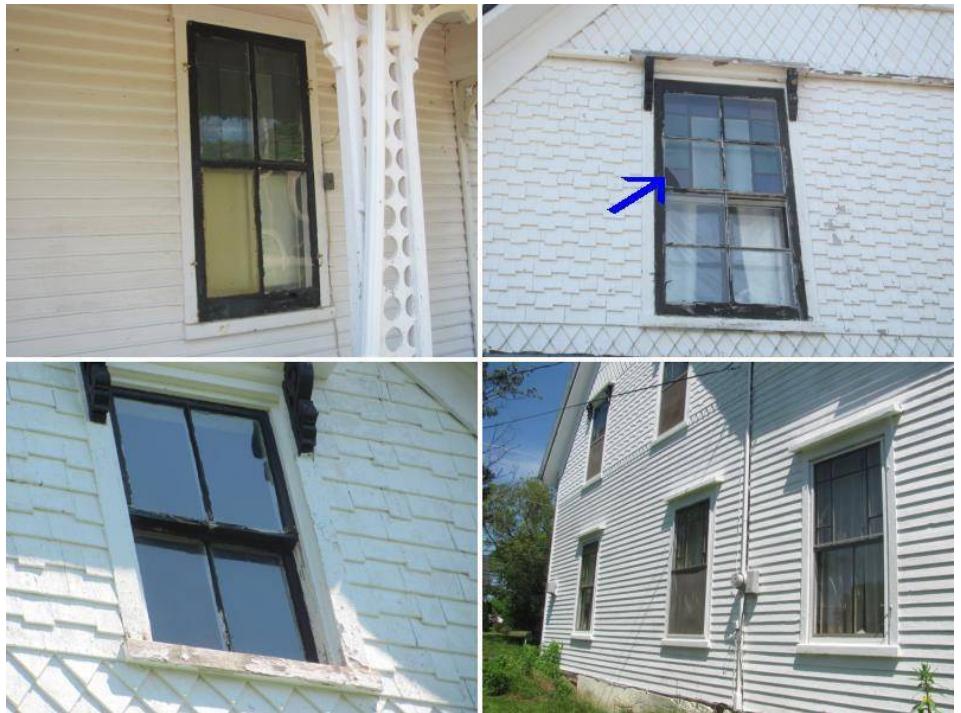
Predominant Type:

Wood single hung. --some have aluminum & wood storms on top.

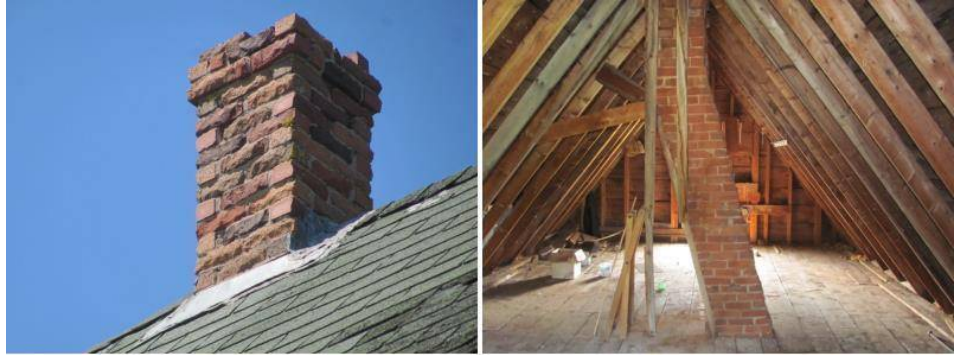
Chimney Exterior:

Chimney is constructed of brick materials. Chimney needs repair of the following deficiencies: Patch cracks in chimney cap, Loose brick noted, Cracking noted, Deteriorated mortar joints are noted. Re-point to prevent further rainwater entry and ongoing deterioration.

Chimney is off set--DID NOT SEE A LINER.THIS MAY NOT BE IN USE ANY LONGER--CHECK WITH OWNER

Recommend repair and further inspection prior to use.

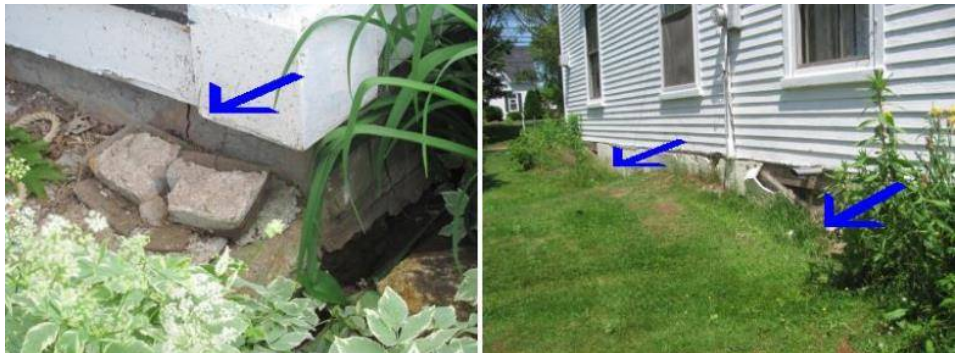
Materials & Condition:

The exposed portions of the perimeter foundation walls need action as there is evidence of failure.(BACK PORCH) + RIGHT SIDE OF HOUSE- (OLD WINDOW WELL) The extent of the damage is not included as a part of this inspection. Further analysis is needed.

Repairs needed.

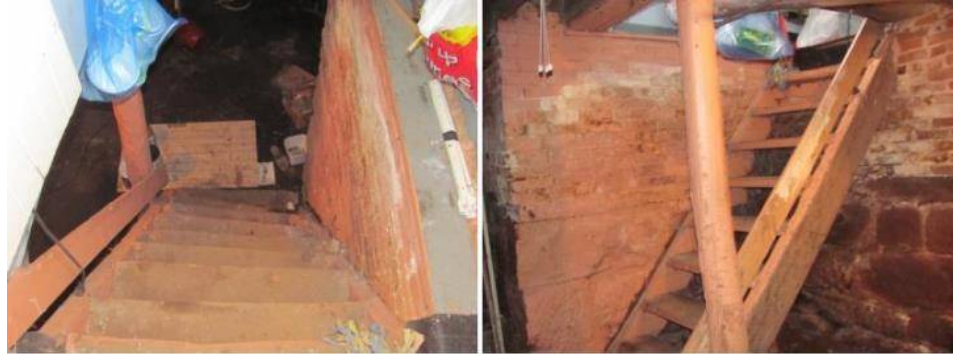
Access:

Basement is fully accessible, Basement is unfinished, Stairs are serviceable, Utility grade construction, There is either no handrail installed, or it needs repair or replacement. Where stairs have no handrail, a danger of falling and resulting injury exists. The staircase is not lighted. For safety reasons, lighting should be installed.

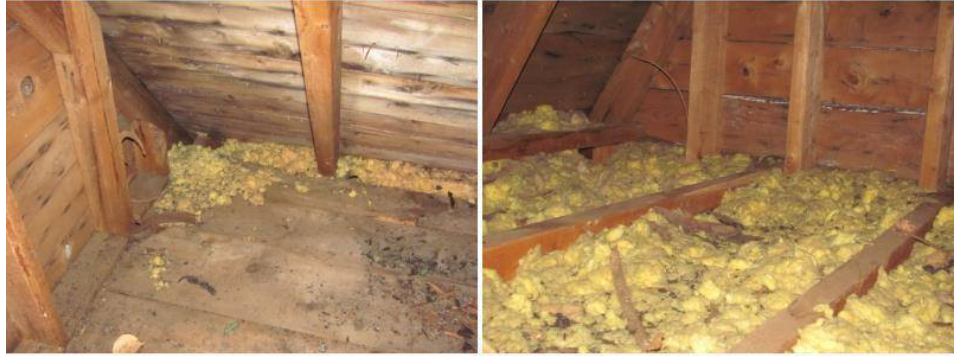
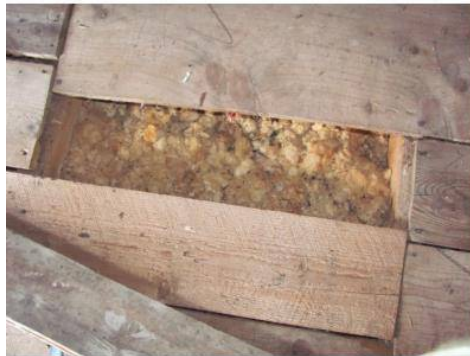
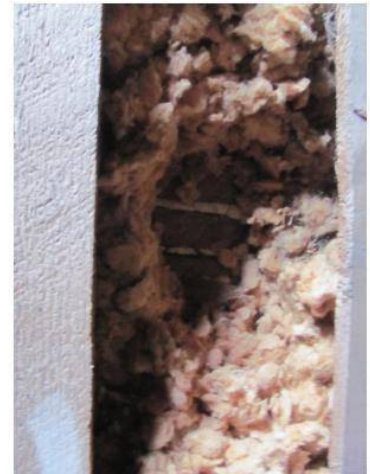
Insulation:

Blown in fiberglass. Insulation is installed between floor joists, There was no vapor barrier noted in the attic cavity. A vapor barrier installed under the insulation on the warm side of the insulation will prevent moisture from rising into the attic from the living space below.

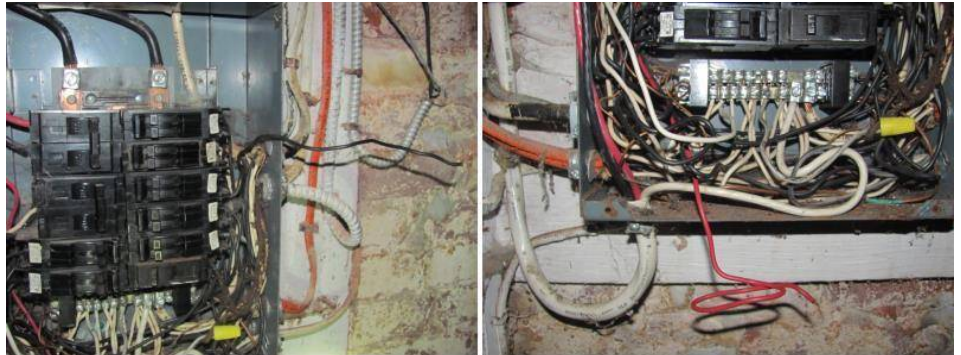
Main Panel Observations:

Damage/defects noted, **Disconnected wiring is noted within the electrical distribution panel** Missing panel cover(s), **Corrosion is noted within the electrical panel. Loose terminals noted, Panels are without the benefit of complete labeling, Electrical system appears outdated by today's standards. Upgrade should be considered. Have a licensed electrician make further evaluation and corrections as needed.**

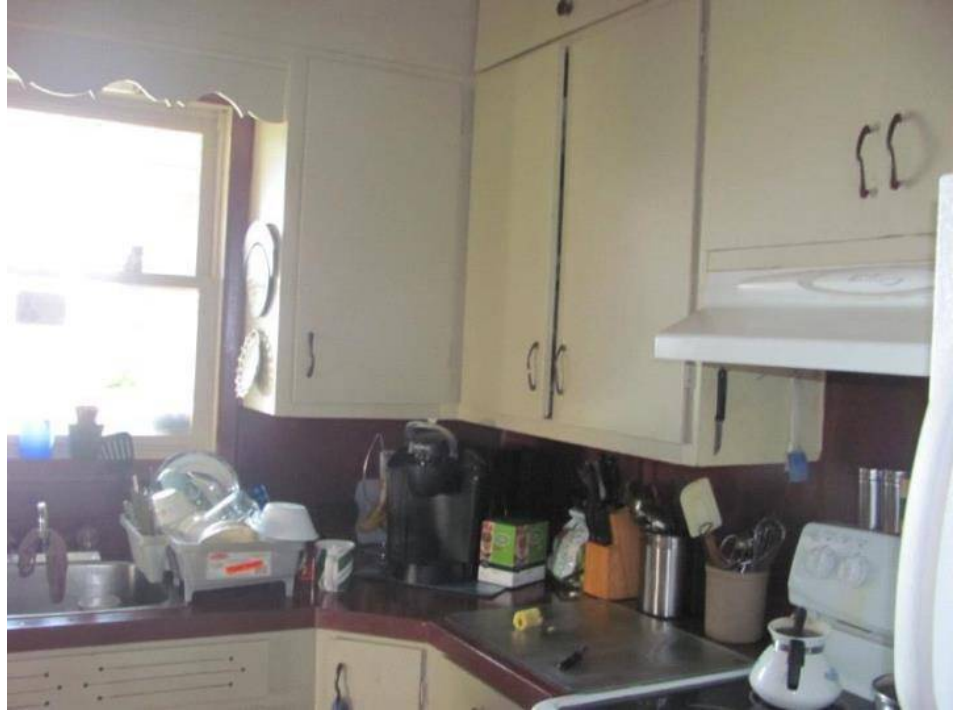
Kitchen Interior:

Ground Fault Circuit Interrupter (GFCI) outlets are recommended for installation at exterior, garage, bath rooms & kitchen outlets. Stored items prevent access and testing at some outlets and switches.

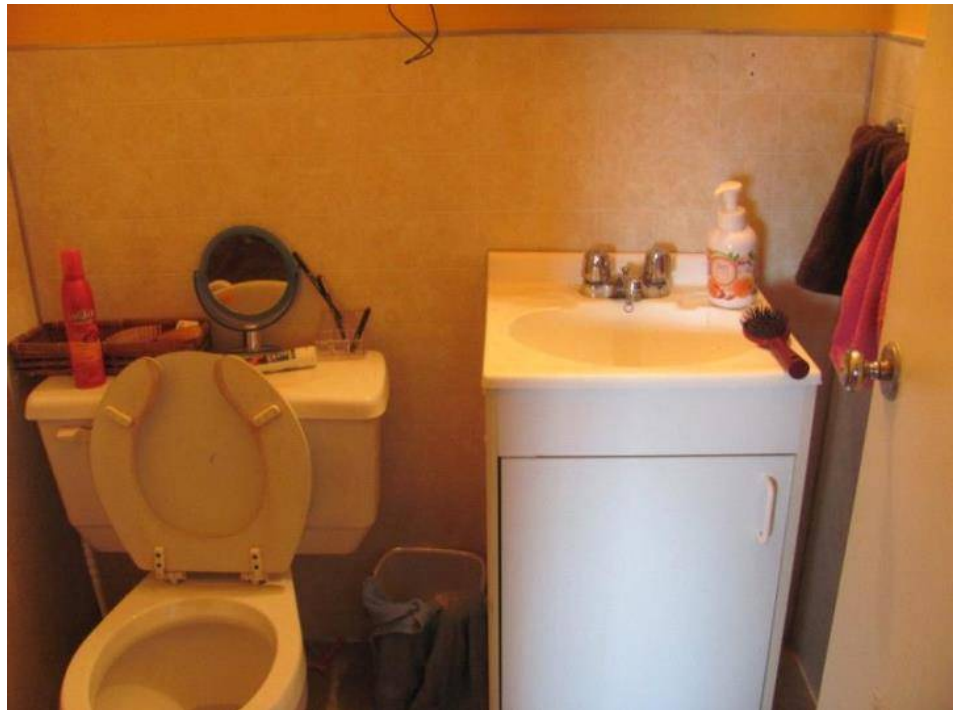
Hall Bath: Downstairs

Ground Fault Circuit Interrupter (GFCI) outlets are recommended for installation at exterior, garage, bath rooms & kitchen outlets.

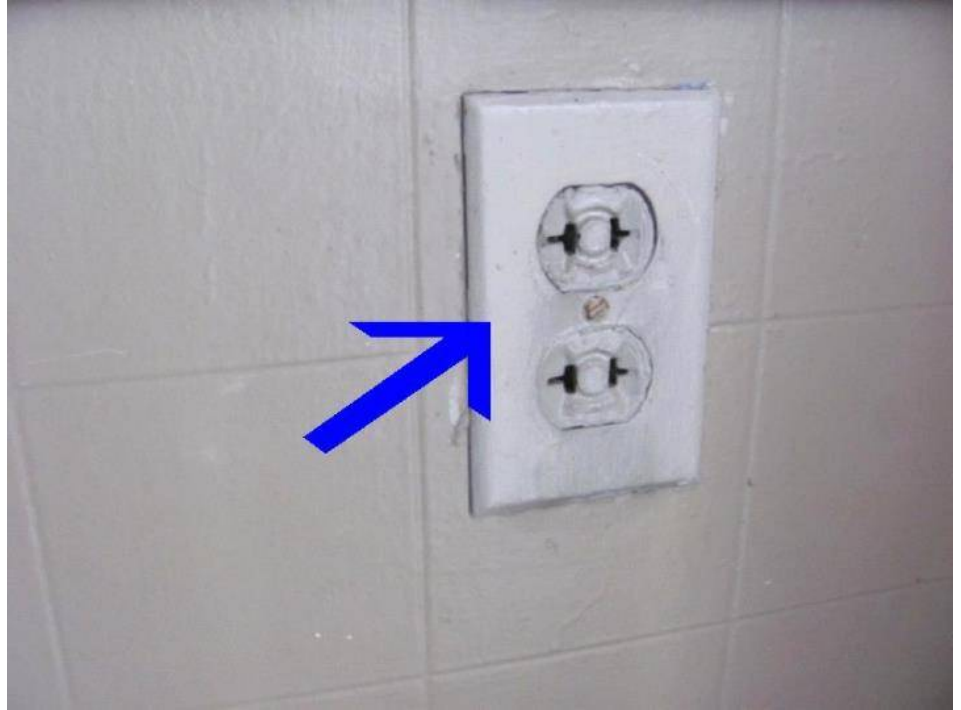
*Bath Between Bedrooms:
Upstairs.*

Ground Fault Circuit Interrupter (GFCI) outlets are recommended for installation at exterior, garage, bath rooms & kitchen outlets.

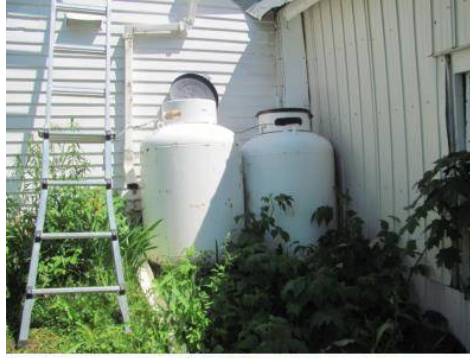
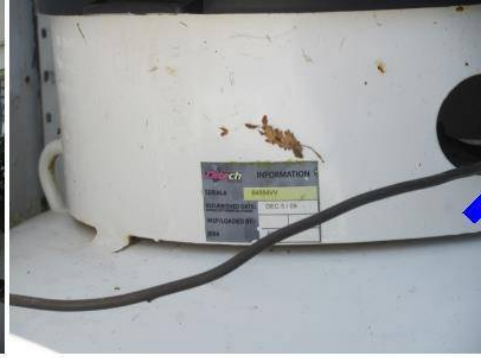
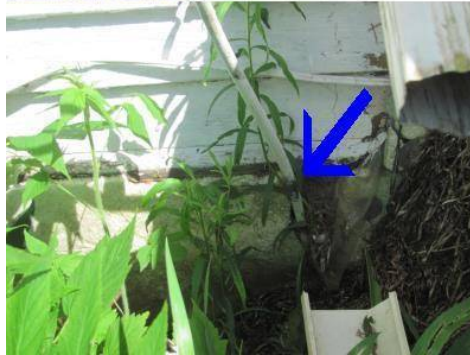
Fuel Source:

Propane. **Pipes are subject to damage where they enter through basement wall.**

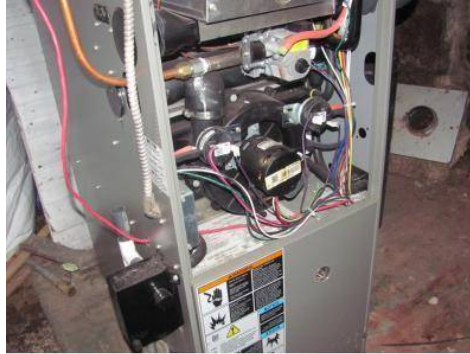
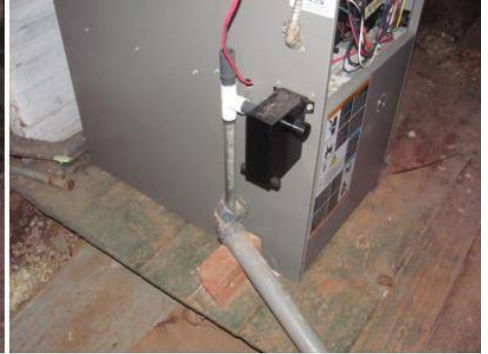
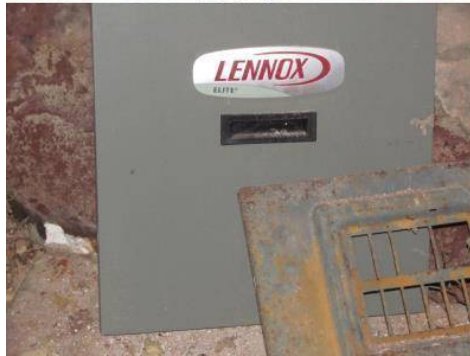
Burners / Heat Exchangers:

Closed System - Unable to inspect, **System has been neglected, with no signs of recent servicing. The heat exchanger portion of a gas or oil fired heater is difficult to access without disassembly, and cannot be adequately checked during a visual inspection. We recommend a service contract be placed on the unit and a heating contractor called to verify the condition of the heat exchanger prior to settlement date. Contact a licensed heating contractor for further evaluation.**

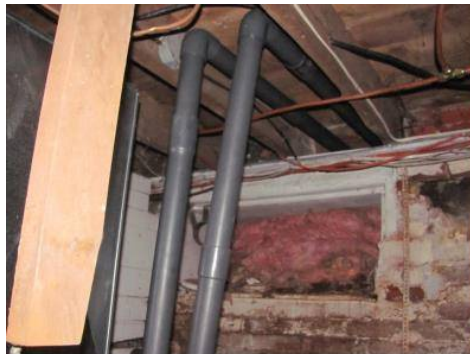
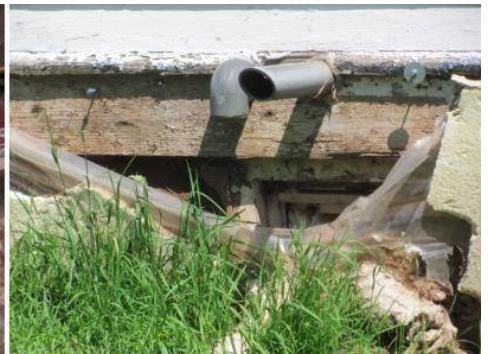
Flues, Vents, Plenum:

Plastic pipe--**CHECK TO SEE IF THIS INSTALLED BY A LICENSED INSTALLER.**

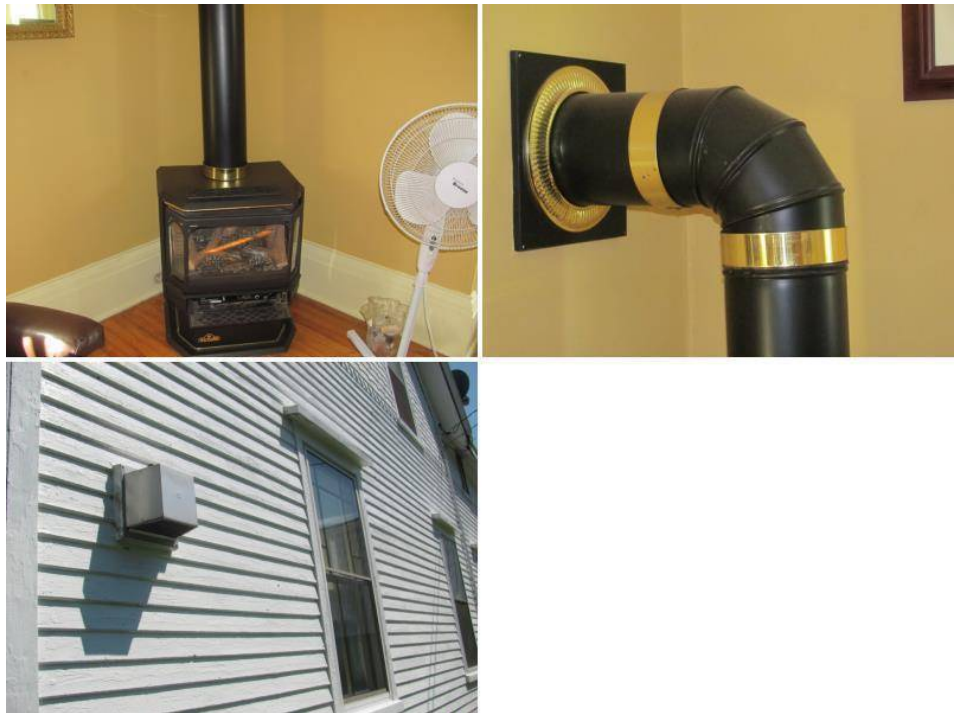
Stove Propane

Appeared Serviceable

THIS WAS NOT TESTED. This should be checked by your insurance agent to make sure it is up to their codes.

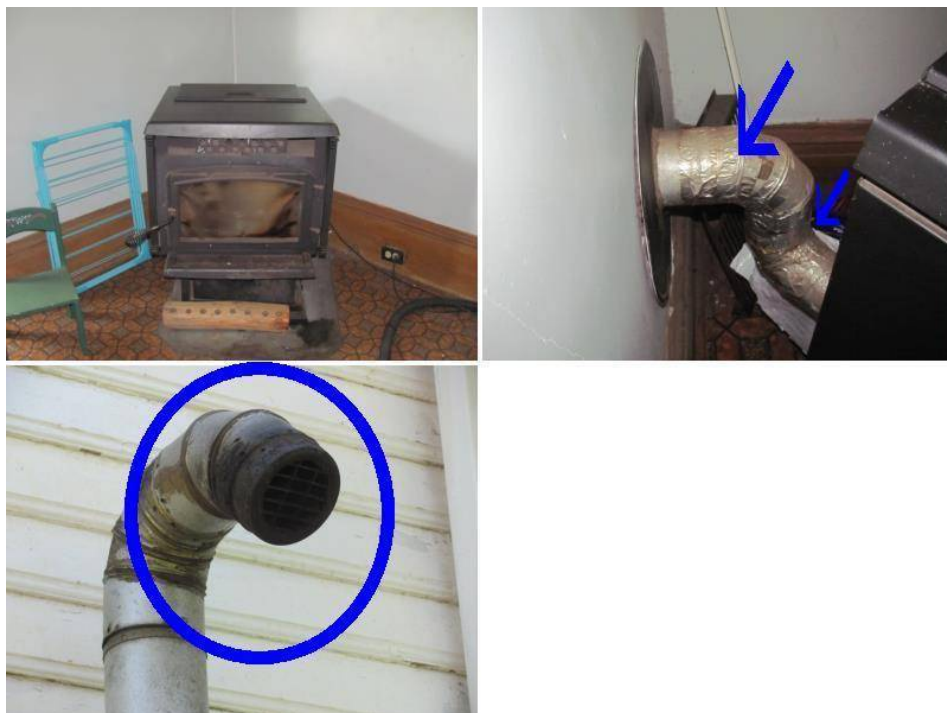
Stove Wood Pellet

THIS WAS NOT TESTED. This should be checked by your insurance agent to make sure it is up to their codes.

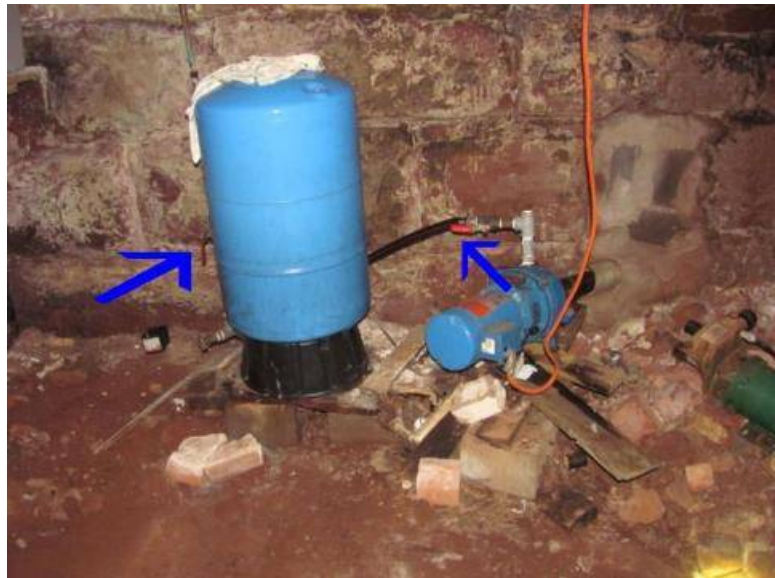
Shut Off:

Main shutoff valve is located in basement on road side.
Plastic.

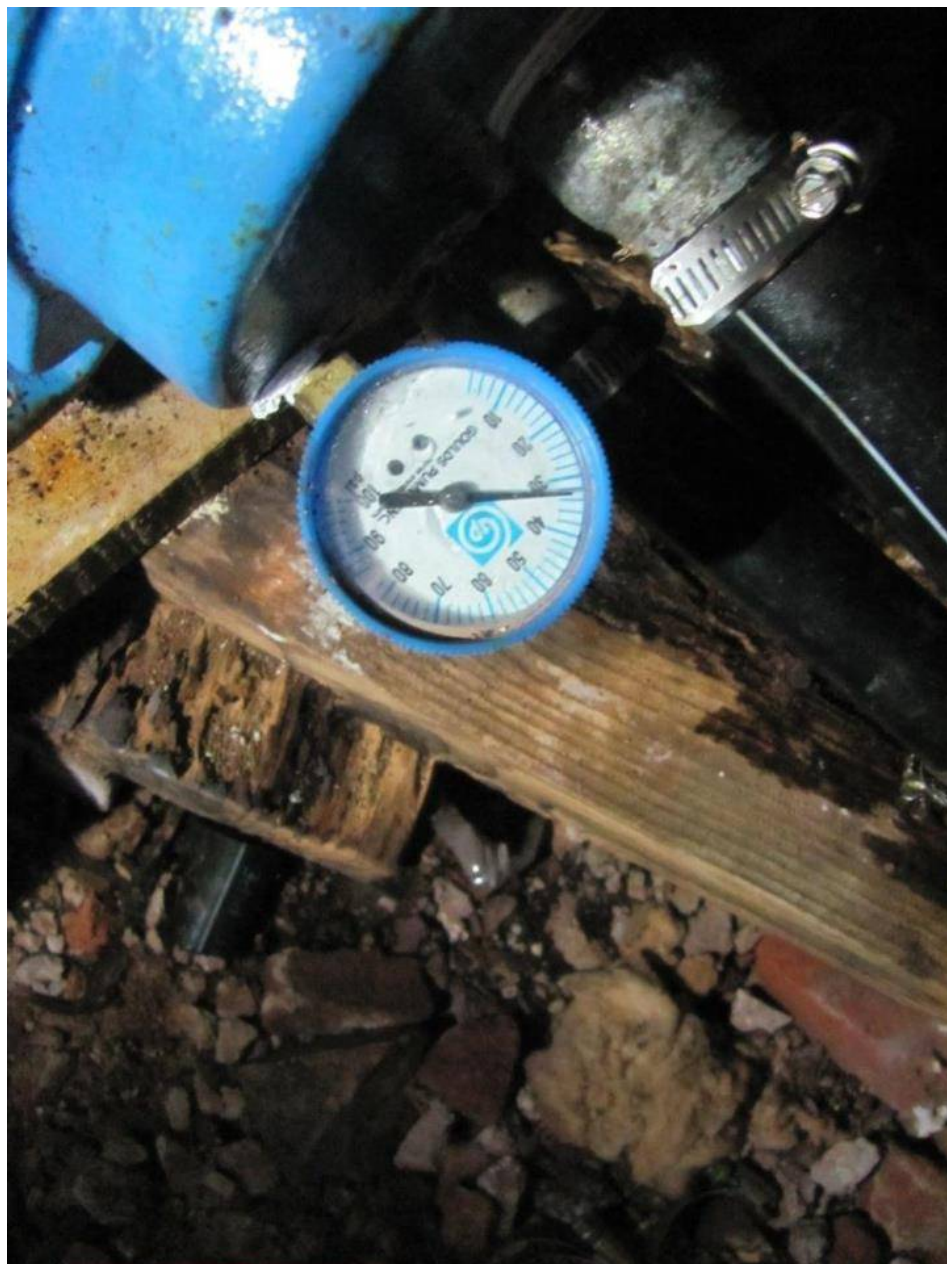
Pressure:

Water pressure from 40 to 80 pounds per square inch is considered within normal/acceptable range. Water pressure was less than 40 pounds per square inch, which is considered low. .

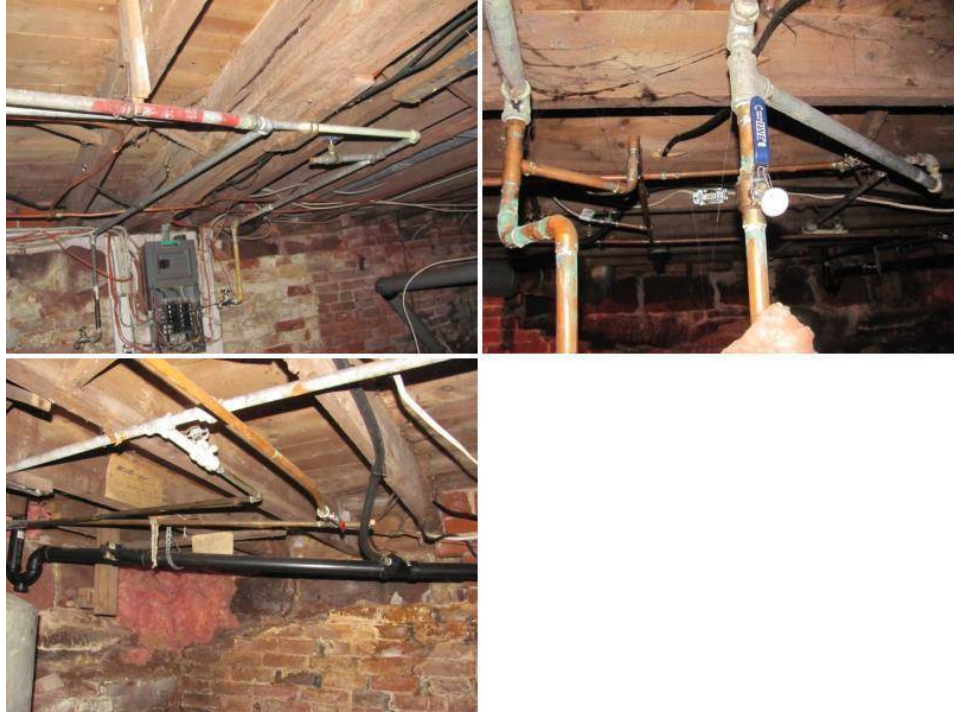
Material:

Combination of materials, Copper, Galvanized, Plastic-
Unable to view all lines.

Minor corrosion is noted, No leakage is noted, but monitor in the
future, Copper/Galvanized piping contact is noted. Correction is
recommend. Defects noted.

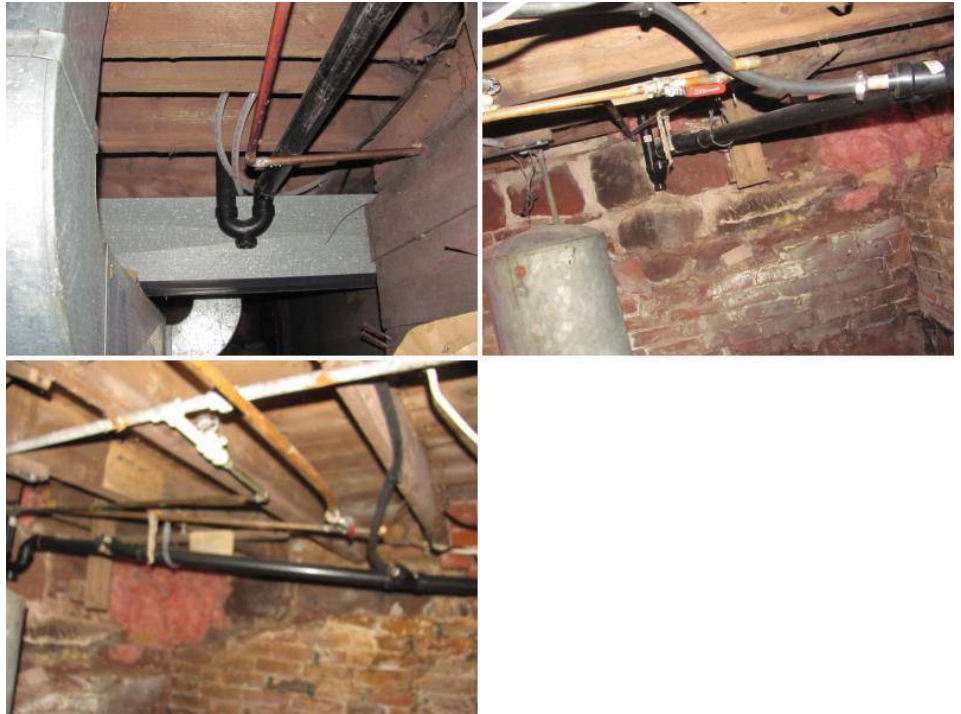
Material:

Galvanized-- Plastic.

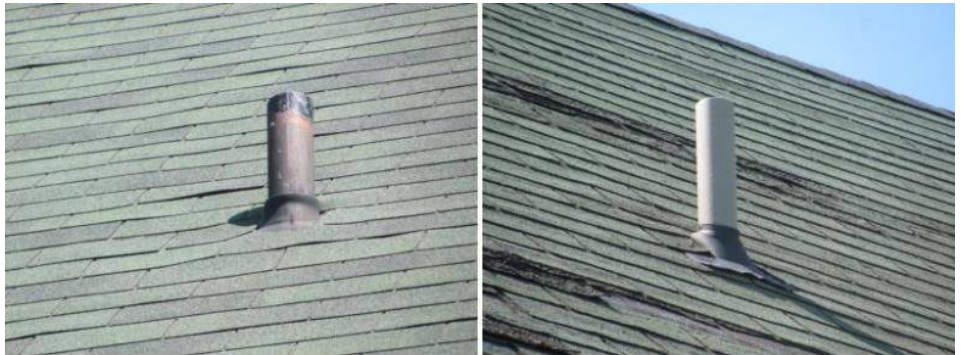
Condition:

Plumbing vents appear serviceable, Unable to fully view pipes.

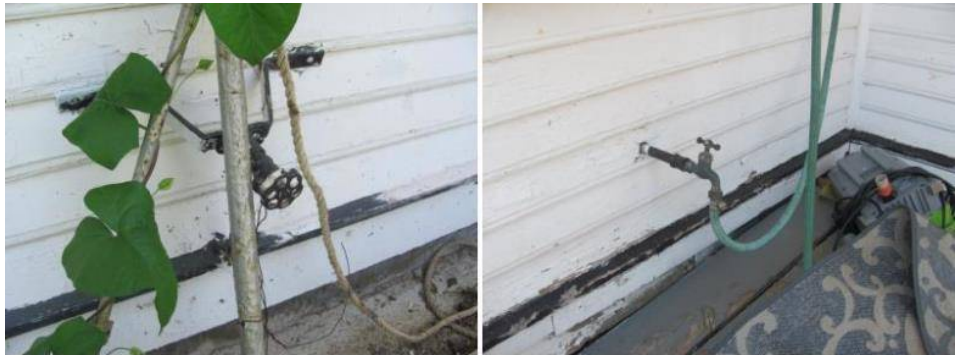
General:

Not a Frost proof type. Cut off type. DO NOT LEAVE HOSE CONNECTED TO FAUCET DURING COLD WEATHER THIS MAY CAUSE THEM TO FREEZE AND CAUSE DAMAGE.

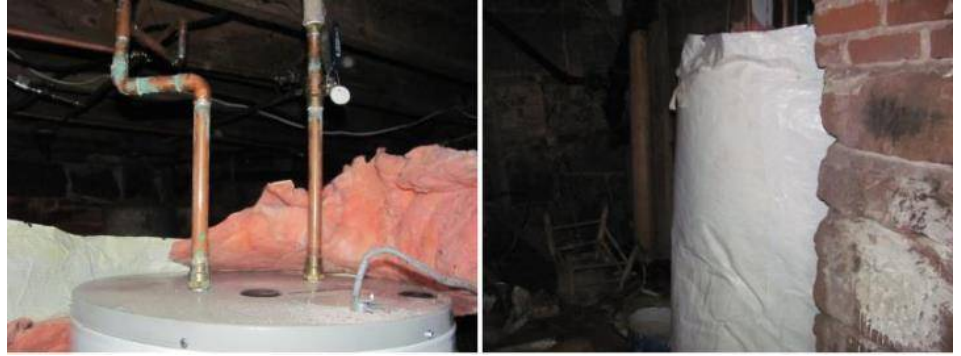
Condition:

Damage/Defects noted, **No pressure relief valve is installed (RECOMMENDED), Thermal blanket installed - unable to fully view tank.**

The temperature pressure relief valve at the upper portion of the water heater is a required safety valve which should be connected to a drain line of proper size terminating just above floor elevation. If no drain is located in the floor a catch pan should be installed with a drain extending to a safe location. The steam caused by a blow-off can cause scalding. Improper installations should be corrected.

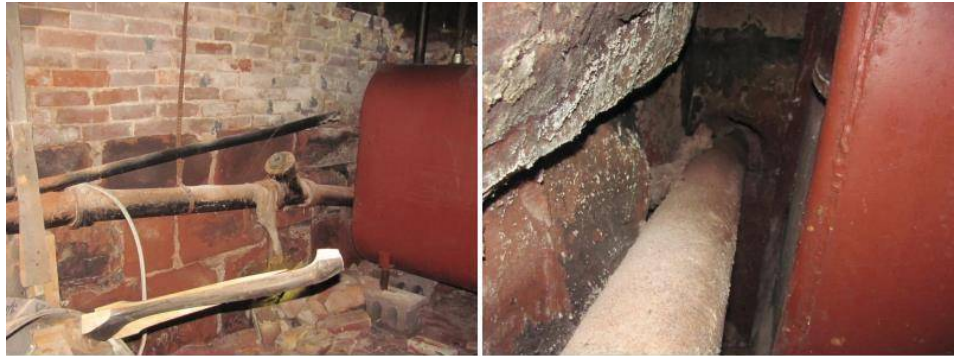
System Condition:

DID NOT SEE A BACK FLOW VALVE--SUGGEST ASKING OWNERS.

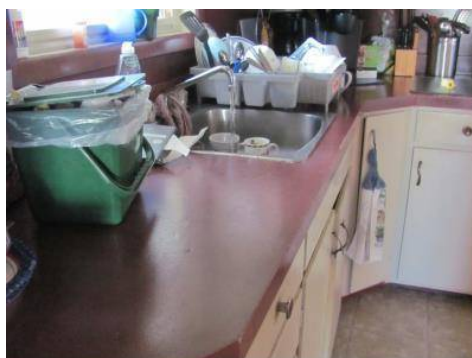
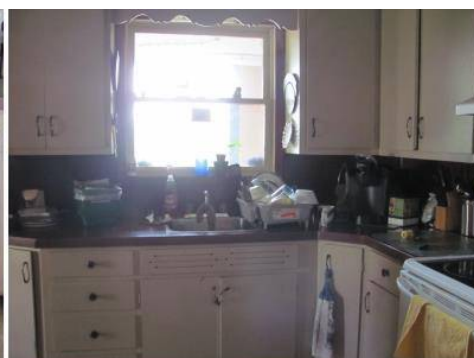
Counters & Cabinets:

Counters are Formica (plastic laminate), with moderate to heavy wear
Cabinets have some damage.

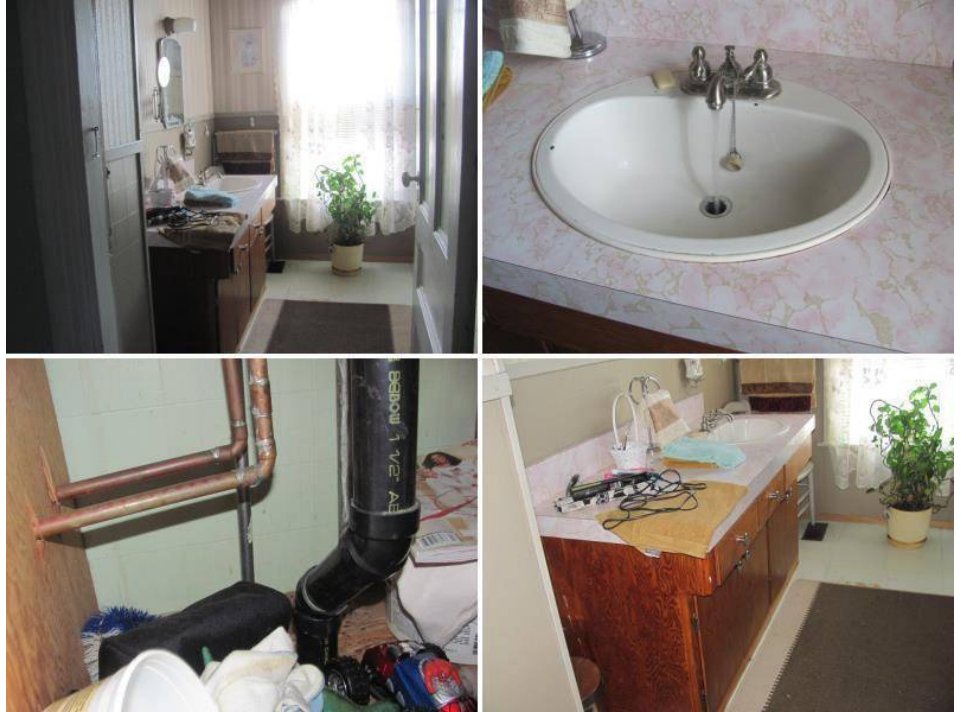
*Bath Between Bedrooms:
Upstairs.*

Counters/cabinets appear serviceable.
Did not see a pee trap.

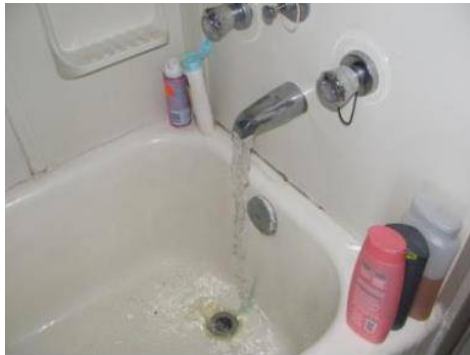
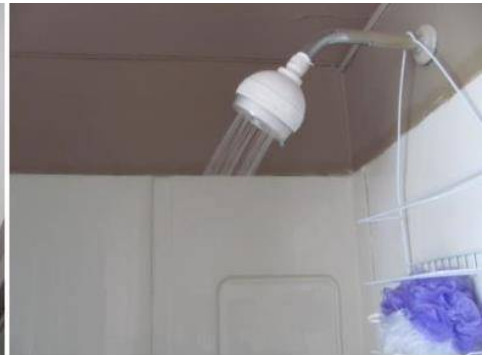
*Bath Between Bedrooms:
Upstairs.*

Older unit--- Shower head replacement is recommended.

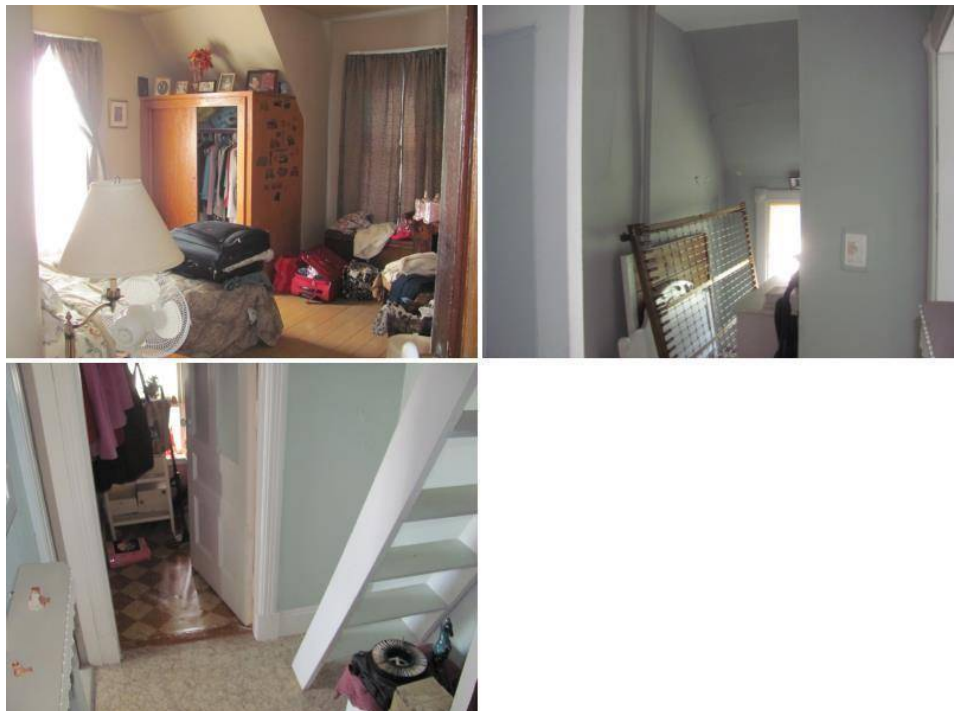
Overall Interior Door Condition:

Appears serviceable.
Some adjustments will be required.

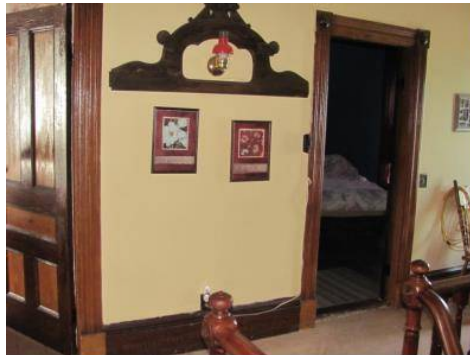
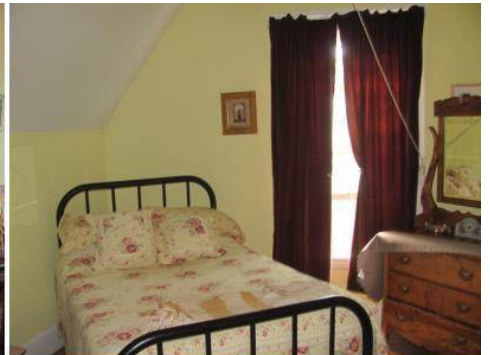
General Material & Condition:

Plaster, Drywall, Paneling, Typical cracks noted, Stored items or furnishings prevent full inspection.

There is minor cracking in the plaster walls. None appears to be the result of a current moisture leakage.

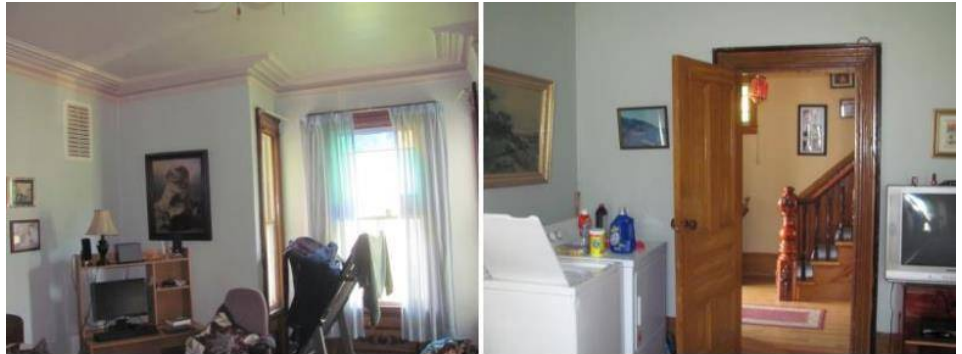
*Other Bath: Downstairs Off
Hallway.*

Appears serviceable.

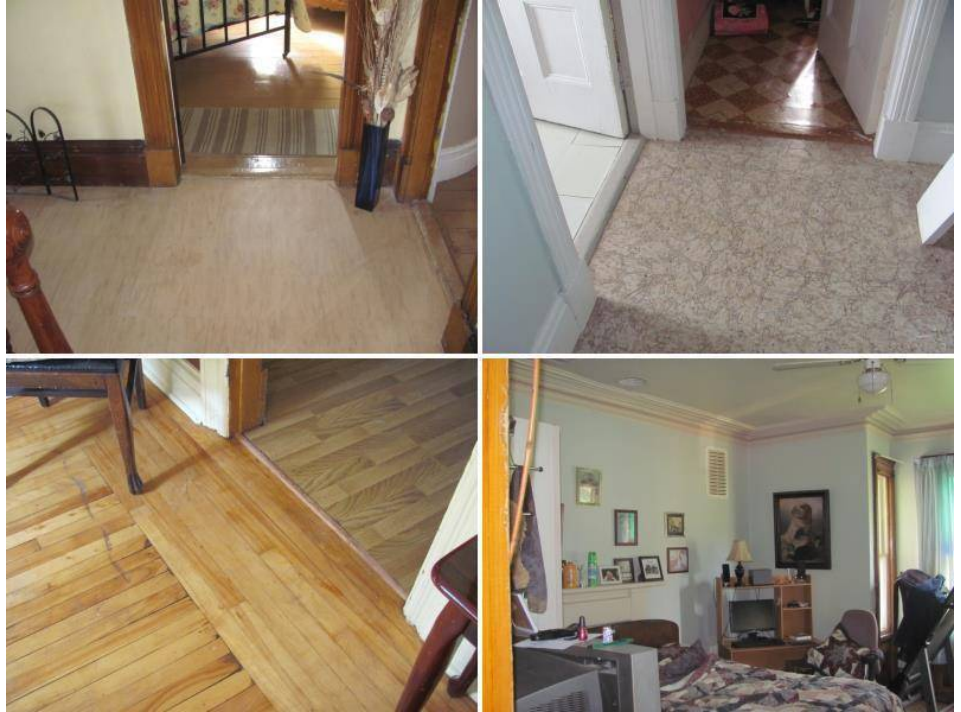
General:

Appears serviceable. Stored items or furnishings prevent full inspection

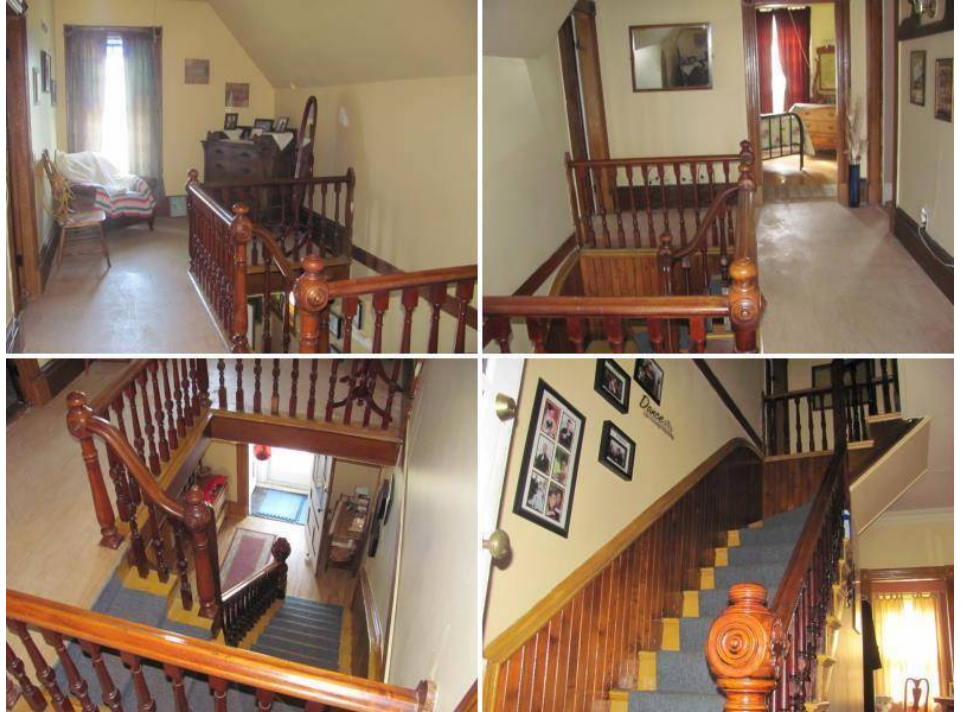
Condition:

Interior stairs serviceable, Stair handrail serviceable.

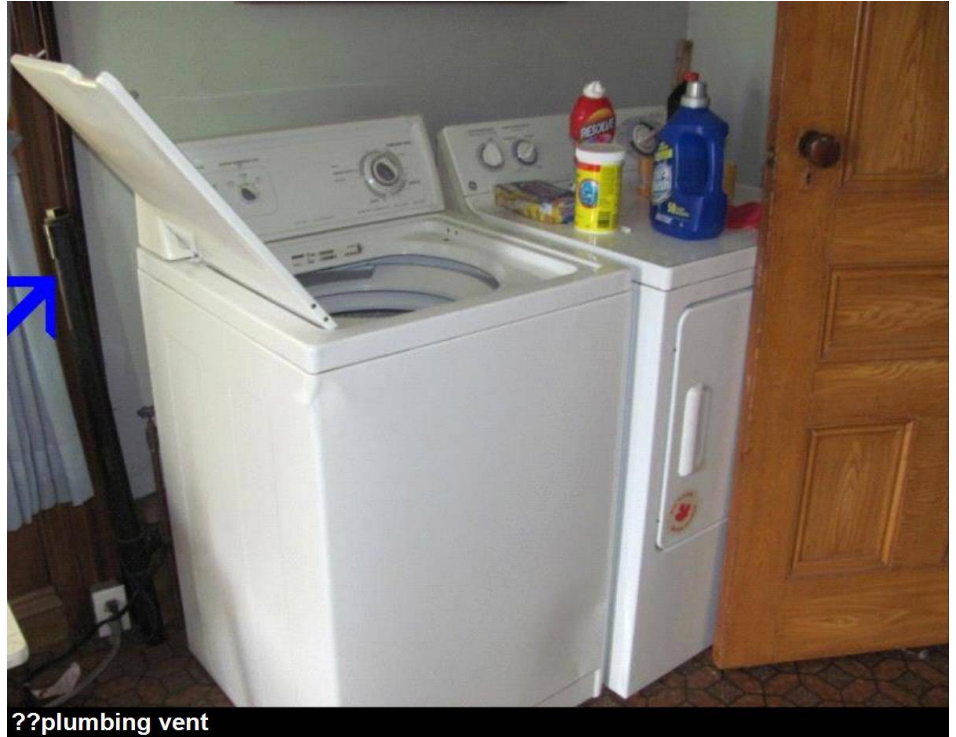
Location:

??plumbing vent

Main floor --room facing road. Dryer venting is provided.

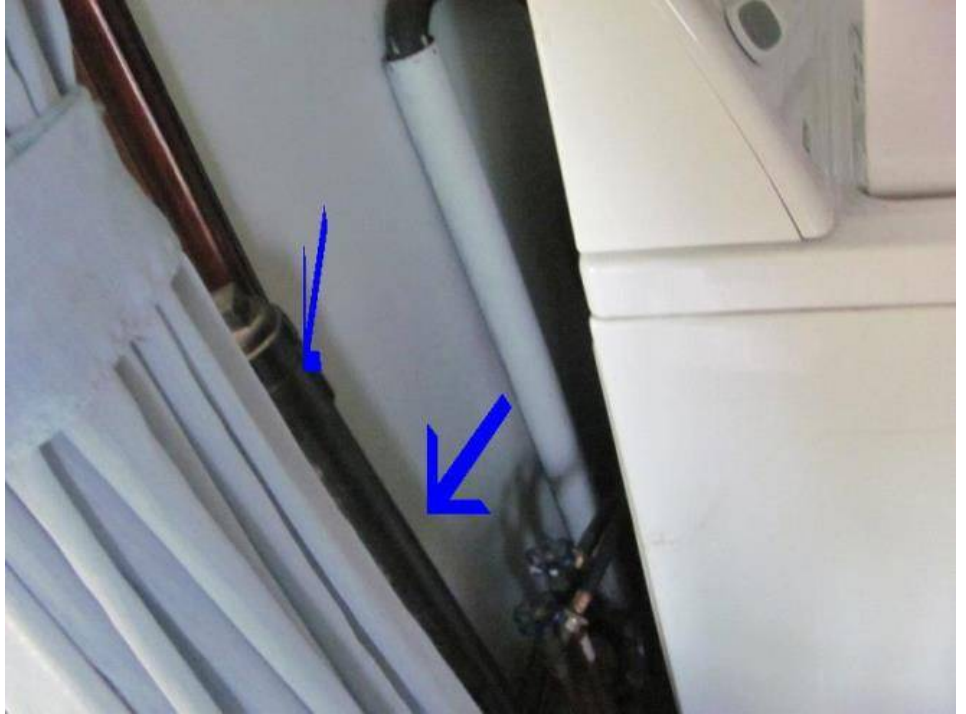
Clothes Washer:

Appears serviceable, Washer was not operated at the time of inspection. ?? **may need some plumbing--??air vent off drain pipe.**

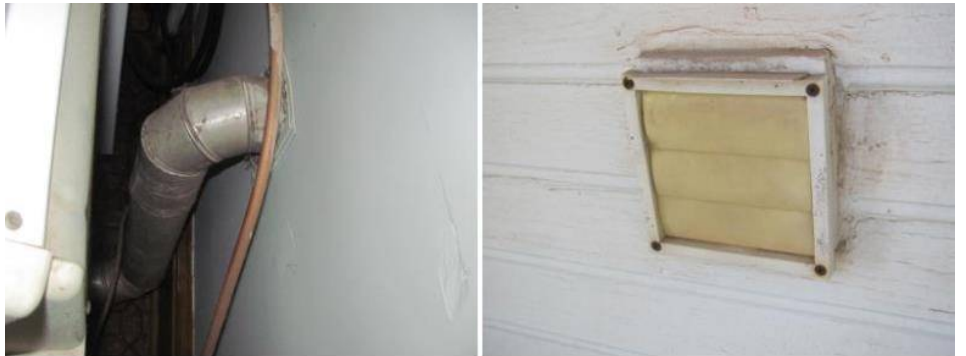
Clothes Dryer:

Appears serviceable, Dryer was not operated at the time of inspection.

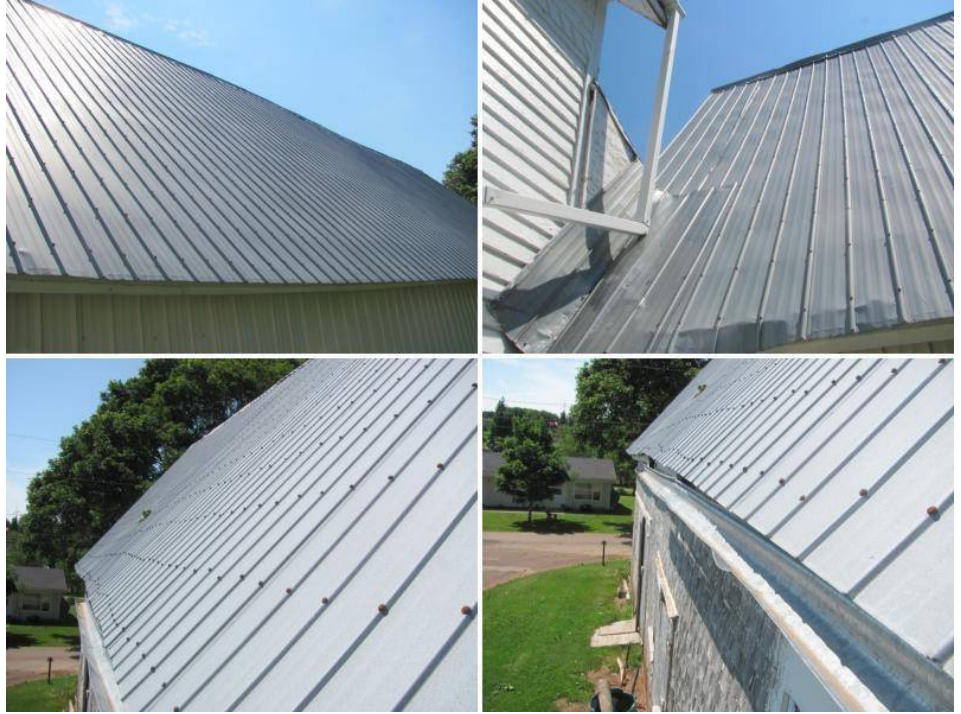
Condition:

Steel-- galvanized --Appears serviceable.

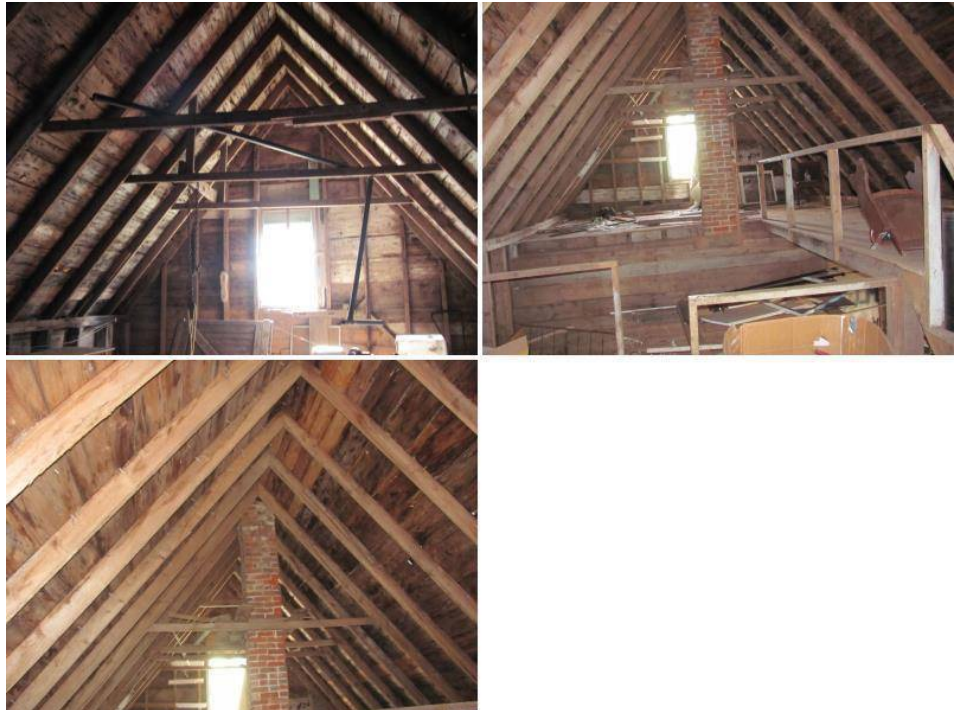
Condition:

Appears serviceable. will need some work---keep an eye on this
